## Aftersales Bulletin

Area **Service Information**  
Subject Aviator Clock Replacement Instructions  
Group 61  
Reference 25 04 2014 - 01  
Published date 06 May 2014  
Version 1  
Department Service Operations/JF  
Recipients All Service Managers, Aftersales Managers and Service Technicians of Rolls-Royce Motor Cars Dealers

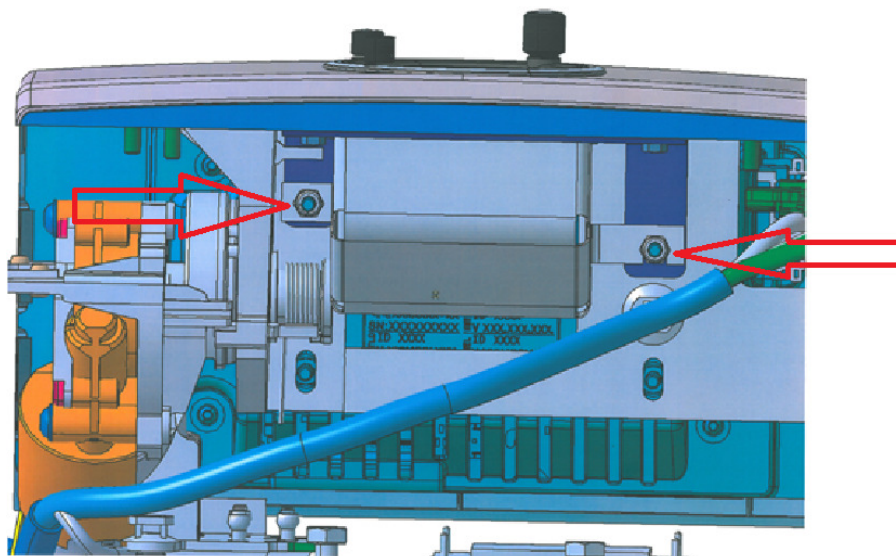
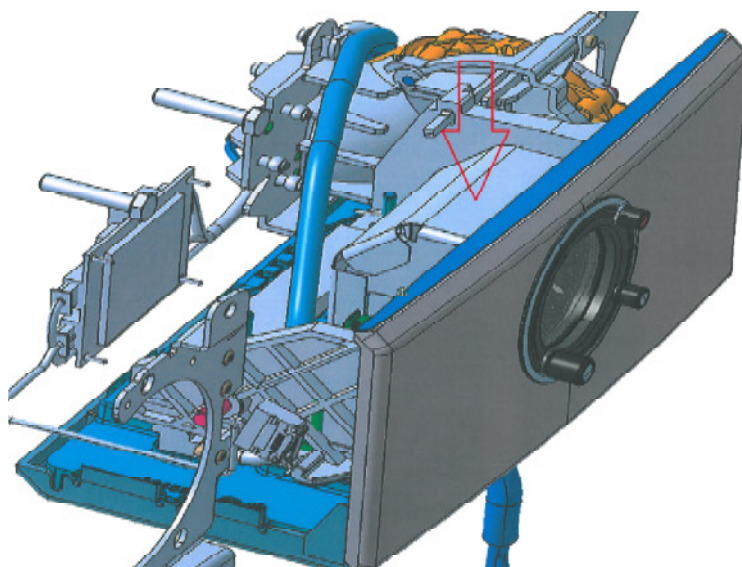
If replacing a clock in a vehicle from the Aviator collection due to a loss of time keeping accuracy, please note that this may be due to magnetic interference created by the centre dashboard audio speaker. A protection set has been created to prevent repeat failures of this kind and should be fitted when the clock is replaced. Please see Parts details for further Parts information.

7. Install the new clock using the removal procedure outlined above in reverse. The only addition is the presence of a protective shield covering the new clock.

**Please note:** the shield is held in place using the CID retaining nuts (see image below). Before fully tightening any screw connections, ensure the clock and Bezel are centralised in the FUM.
