**SUBJECT****Driver's Side Exterior Door Handle Cover Cap Is Loose****MODEL**

F56 (Cooper, Cooper S)

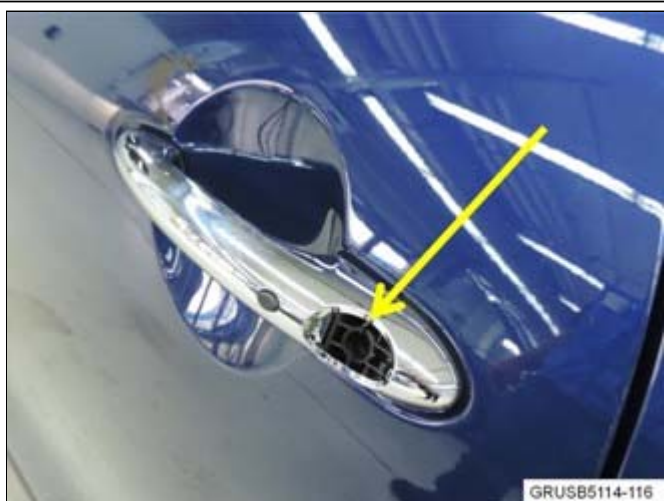
1. The driver's side exterior door handle cover cap is loose or missing.
