Washer Fluid Leaks from Front Washer Jets

F56 (Cooper, Cooper S)

Produced from October 31, 2013 to March 30, 2014

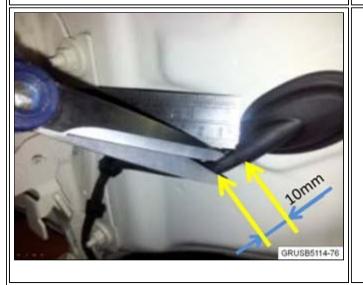
1. Open the bonnet. Locate the washer hose to be modified near the passenger's side gas strut, attached to the bonnet. See the area circled in black.
