### Automatic Deactivation of Recirculation Mode

R55 (Cooper Clubman)

With option 0534 (automatic air conditioning)

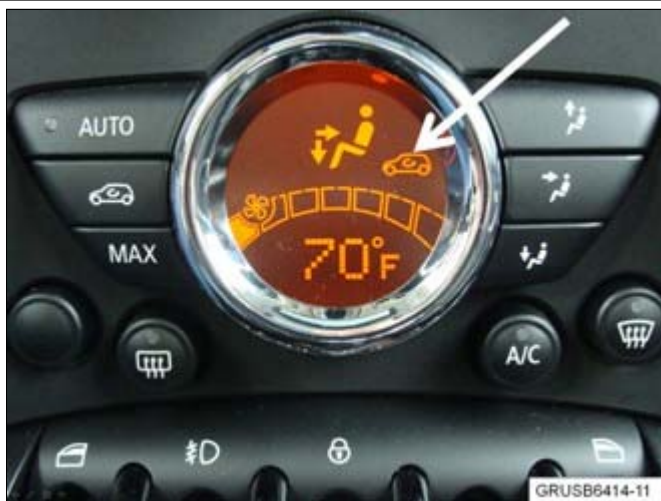
1. The recirculation display is shown when the recirculation button is pushed. It will automatically switch recirculation off after a few minutes, depending on interior and exterior temperatures, to allow fresh air to enter the cabin. This feature was added to reduce the amount of condensation and fogging on the inside of the windows.

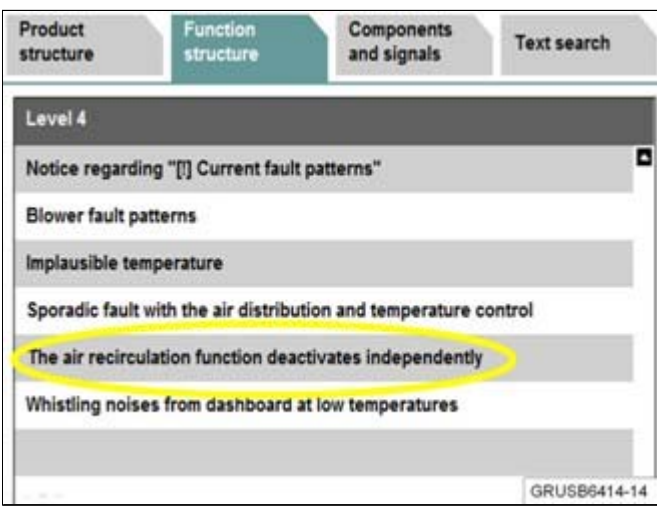
5. Select "The air recirculation function deactivates independently."
