Service Action: Replace Wheel Bolt Wrench

F56 (Cooper)

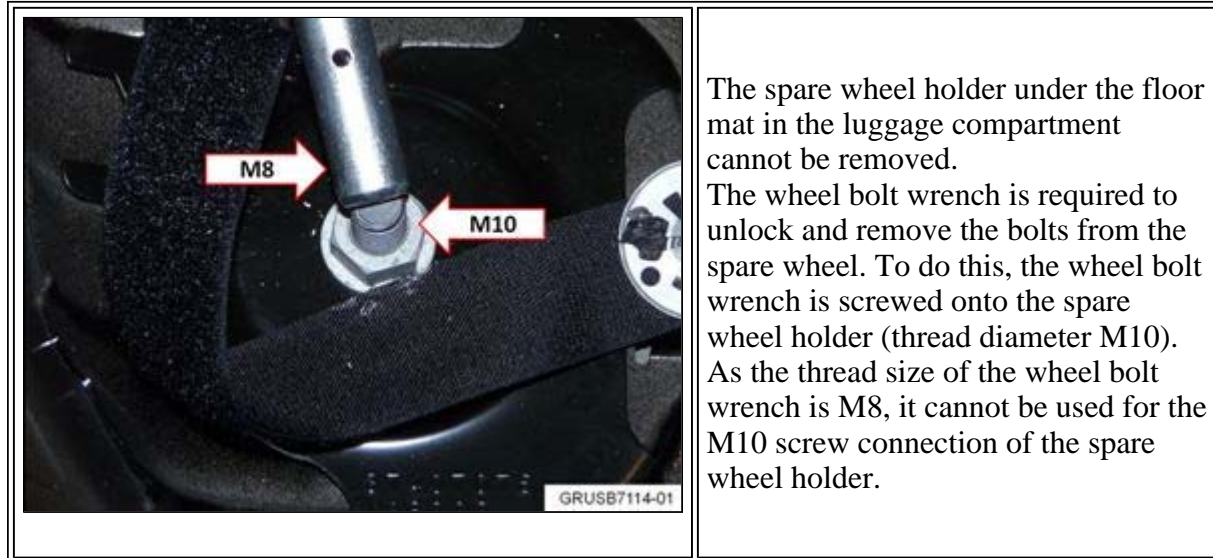
The internal thread of the wheel bolt wrench is incorrect at M8.

The spare wheel holder under the floor mat in the luggage compartment cannot be removed.

The wheel bolt wrench is required to unlock and remove the bolts from the spare wheel. To do this, the wheel bolt wrench is screwed onto the spare wheel holder (thread diameter M10). As the thread size of the wheel bolt wrench is M8, it cannot be used for the M10 screw connection of the spare wheel holder.

Replace the wheel bolt wrench in the vehicle tool kit.
