| Measure no. | Subject | |
|---|---|---|
| US 58371638-01 | Two lashing straps under pillion seat discontinued | |

#### Vehicles affected

| E series | Engine | Body |
|---|---|---|
| K42 K46 K46/11 | | |

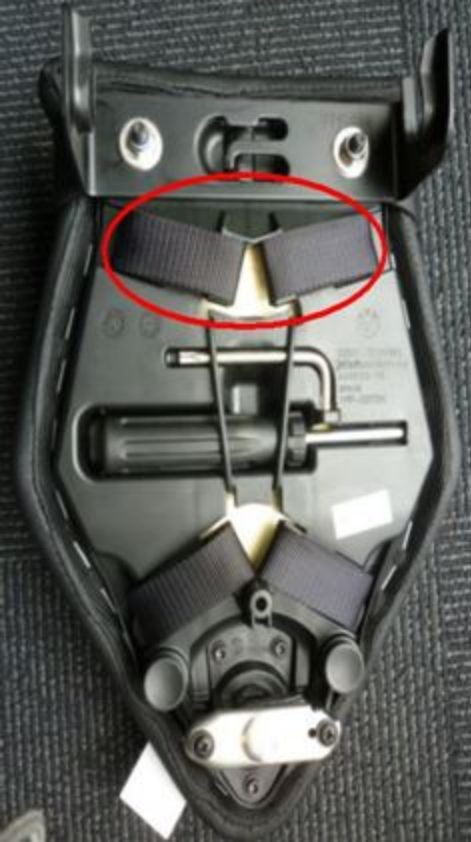
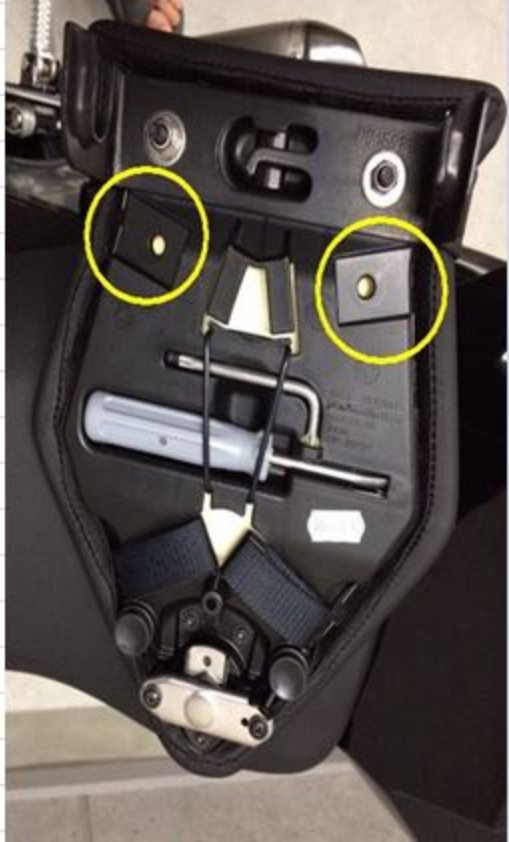
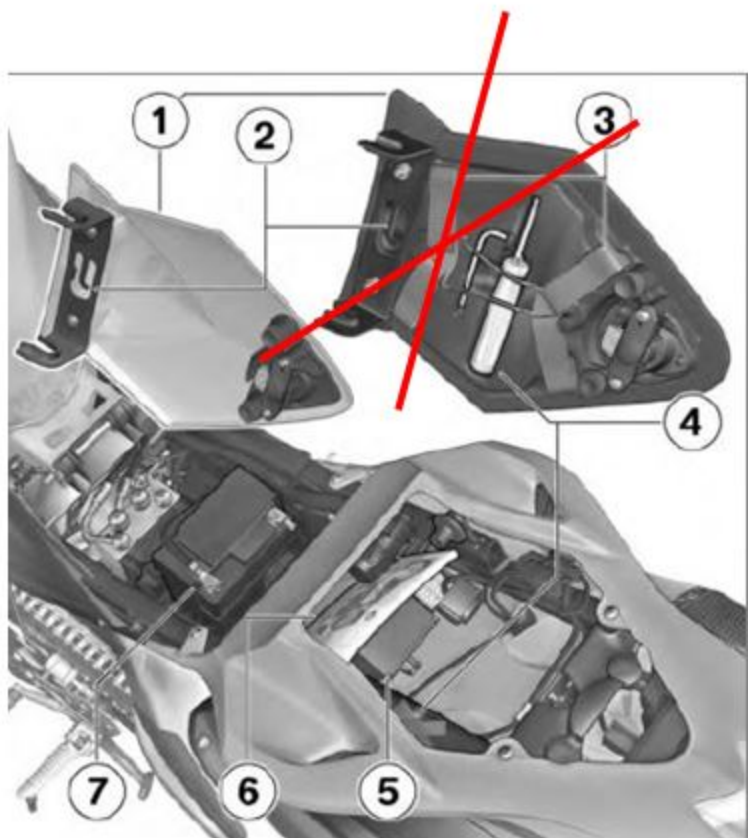
There are only two lashing straps riveted down under my pillion seat instead of four.

The part has changed. When viewed in the direction of travel the two front lashing straps have been discontinued (see accompanying pictures).

Do not replace any parts and additional straps are not to be secured to a seat that has been fitted with two straps.

To securely lash luggage to the pillion seat, the customer should use the rear straps with extensions to the pillion passenger footrests.

The left-hand lashing strap should be secured to the right-hand pillion passenger footrest and vice versa.
