Wind Noises

F15 (X5)

Produced from June 30, 2013

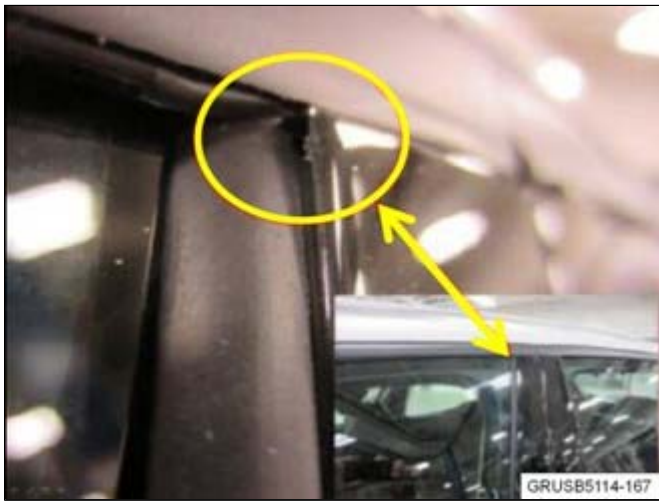
A wind noise above 35 mph may occur if a gap between the upper corner area of the window seal and the B-pillar can be seen.

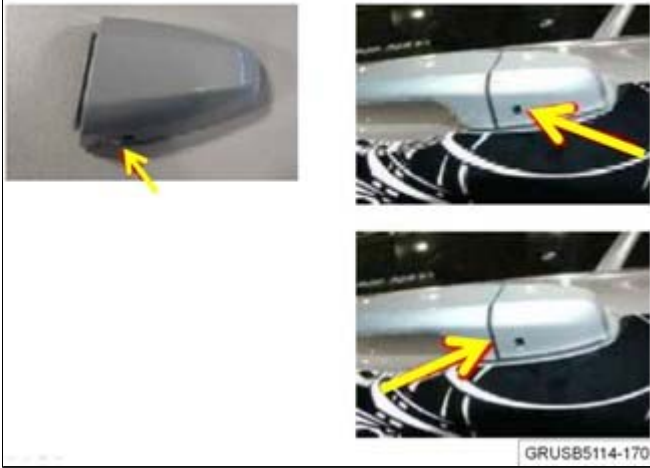
GRUSB5114-170

The driver's door handle may create a high-pitched whistling noise when driving at highway speeds. The high-pitched noise is generated from the two areas shown.

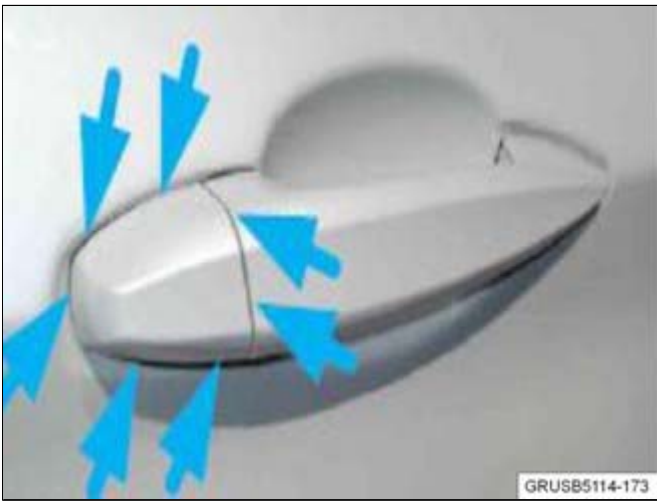
The front passenger and rear door handles may also generate wind noises from the cover cap by allowing air to enter the door.
