**SUBJECT****Front Door Makes Rattling Noise****MODEL**

I01 (i3)

I01 (i3 REx)

Produced from September 1, 2013 to April 27, 2014

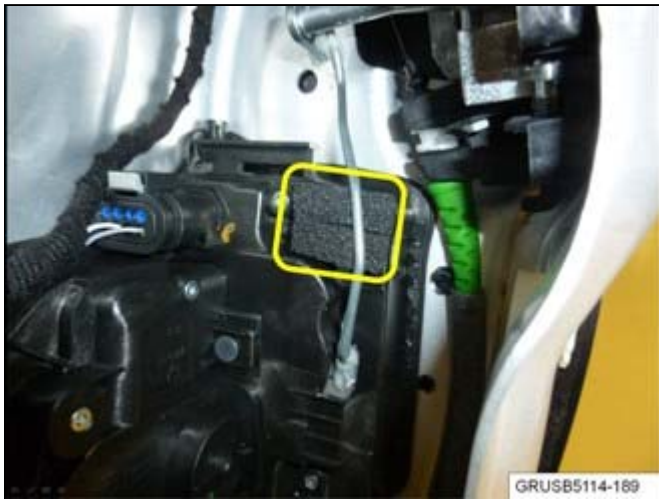
The door lock actuating rod vibrates/rattles against the door lock.

7. Prepare two pieces of the self-adhesive dampening strips (approx. 3 x 8 cm) and apply to the door lock to the area shown.
