### Vehicle Only Starts when Remote Key Held Against Column

F30 (3 Series Sedan)

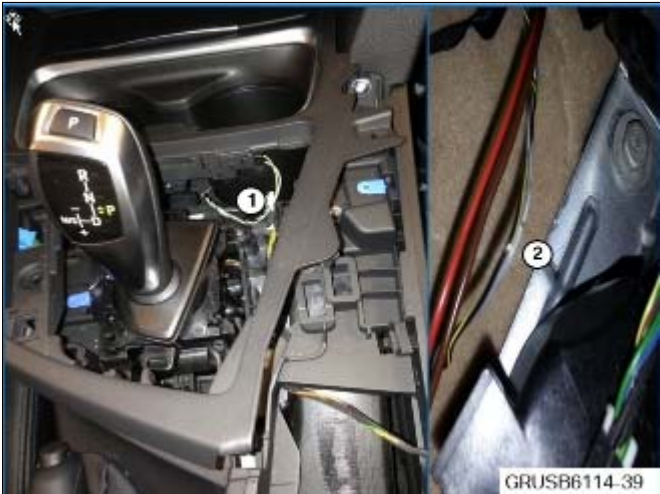
The antenna (aerial) in the passenger compartment near the front of the center console has shorted wiring.

<ol style="list-style-type: none"> <li>3. Remove the center console trim cover and gain access to the aerial wiring (1).</li> <li>4. The wiring harness gets shorted against the metal bracket (2).  Note: (2) is a close-up of the area indicated in (1).</li> <li>5. Repair the wiring harness. Position the harness away from the metal bracket.</li> <li>6. Clear the faults. Check the Comfort Start function.</li> </ol>
------------------------------------------------------------------------------------	----------------------------------------------------------------------------------------------------------------------------------------------------------------------------------------------------------------------------------------------------------------------------------------------------------------------------------------------------------------------------------------------------------------------------------------

Isolate the shorted wires and repair as needed.
