This Service Information bulletin supersedes SI B64 06 13 **dated March 2014.**

**A/C Cooling: Intermittent Reduction of Air Flow**

F30 (3 Series Sedan)

Produced from July 4, 2012 to September 2, 2013

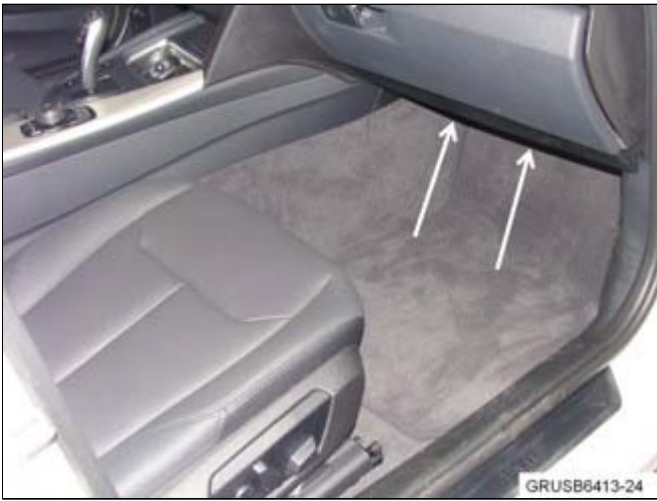
1. **NEW** Remove the passenger's side footwell cover trim (the bottom instrument panel trim).

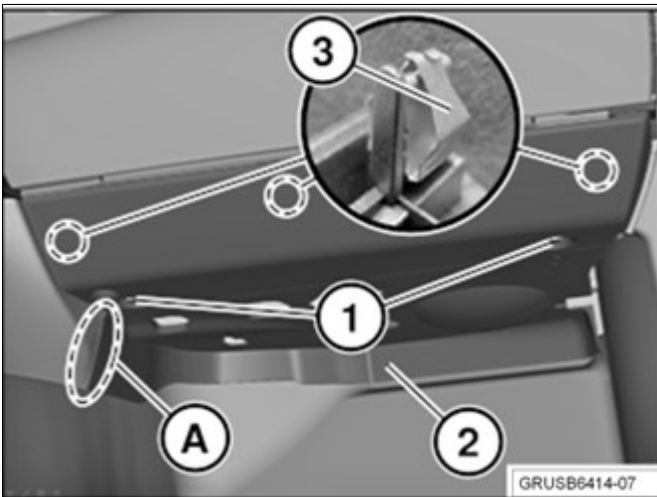
2. Remove both screws at connection (1).

**Note:** With the knee airbag, also remove both nuts (1).

Tightening torque is 5Nm.

Release the trim panel (2) at clamps (3). Feed out the trim panel (2) in area (A) toward the bottom.

Lower the trim panel (2) slightly and disconnect the plug connections behind it.

**Installation note:**  
Feed in the trim panel (2) in area (A) correctly behind the center

console.

Clamps (3) must not be damaged.

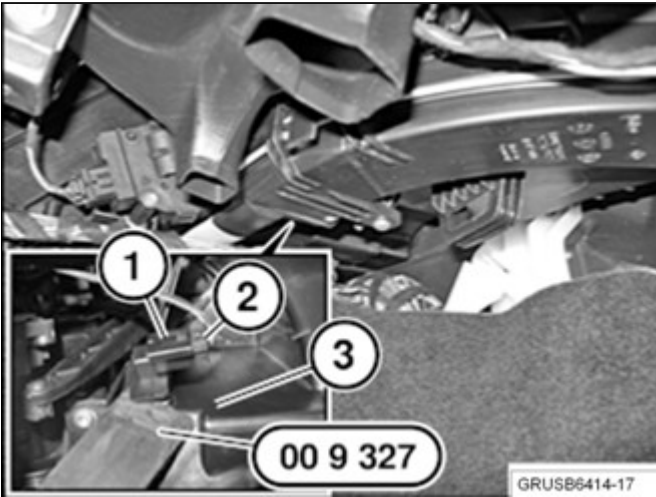
3. Disconnect the plug connection (2). Unclip the evaporator temperature sensor (1) with special tool 00 9 327 from the heating and air conditioning unit (3), and remove.

Installation note:

Ensure the evaporator temperature sensor (2) is correctly seated.

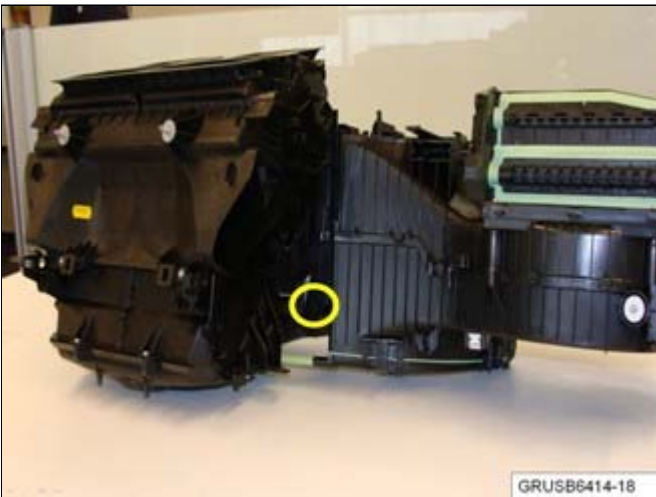
4. The IHKA housing (removed for clarity) shown is viewed from the passenger's side. The circle shows the approximate location of the evaporator temperature sensor.

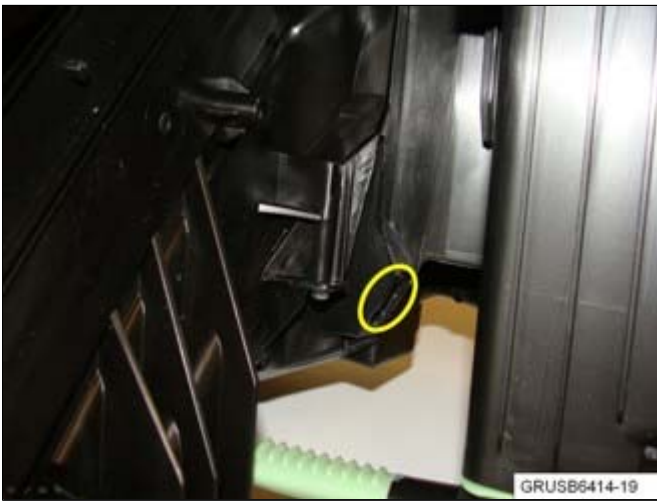
5. The close-up picture shows the exact location (circle) of the sensor opening. The following steps will be performed from the lower passenger's footwell area at the bottom of the IHKA housing.

**Note:** As a reference point, the evaporator temperature sensor is located just above the white ribbed rubber water drain hose, when viewed from below.

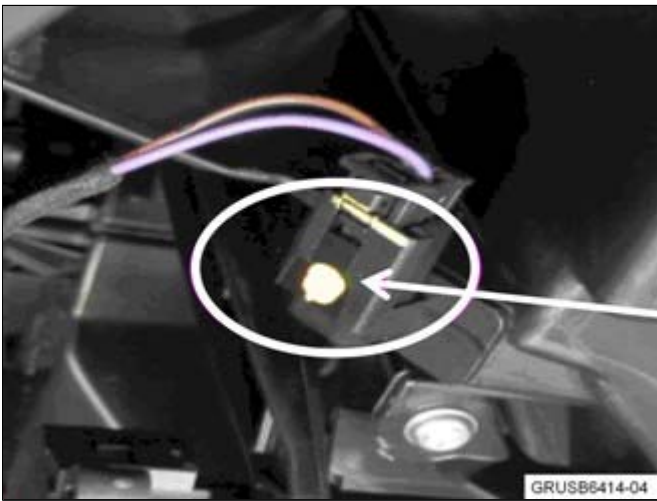
7. Check for a marking on the electrical connector. If a mark is seen or **NO** gap exists, the IHKA housing must be modified.

**Do not replace any parts. The repair procedure includes installing a new adapter to correct the gap.**
