Service Action: i3 Business Navigation – Retrofit

I01 (i3 REx)

Produced to 06/06/14

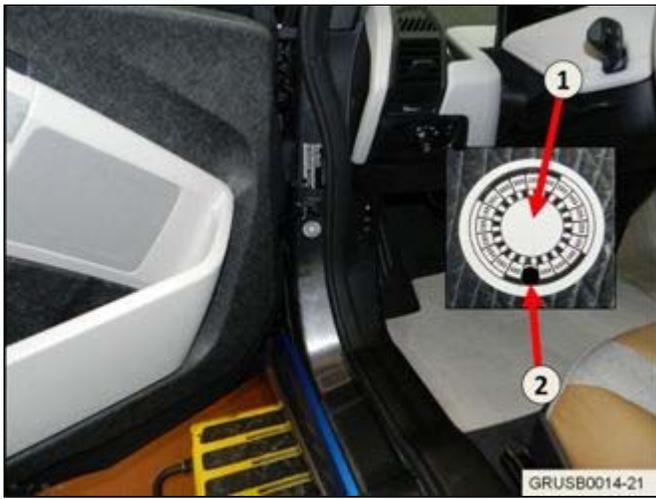
- A. Emboss your BMW center warranty number in the middle of the label (1);
- B. Punch out code number **689** (2), printed on the label; and
- C. Affix the label to the A-pillar as shown.
