This Service Information bulletin supersedes SI B65 16 14 **dated July 2014.**

Central Information Display Intermittently Dimming or Flashing Off/On

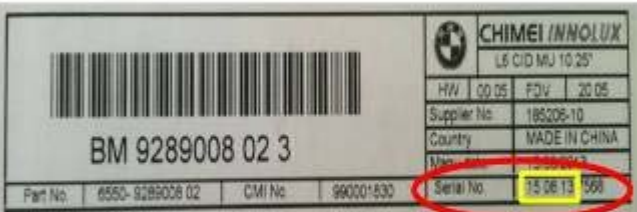
Part No.	6550-9289008 02	CMI No.	990001630
Serial No.	15 08 13 560

Affected Central Information Displays were manufactured from 02/01/2013 to 06/09/2014. The manufacturing date is included in the serial number printed on the parts label on the CID.
IMPORTANT: The manufacturing date is written in the following way: dd mm yy
 Example: The manufacturing date of August 15, 2013 is printed on the label in the following way: 15 08 13

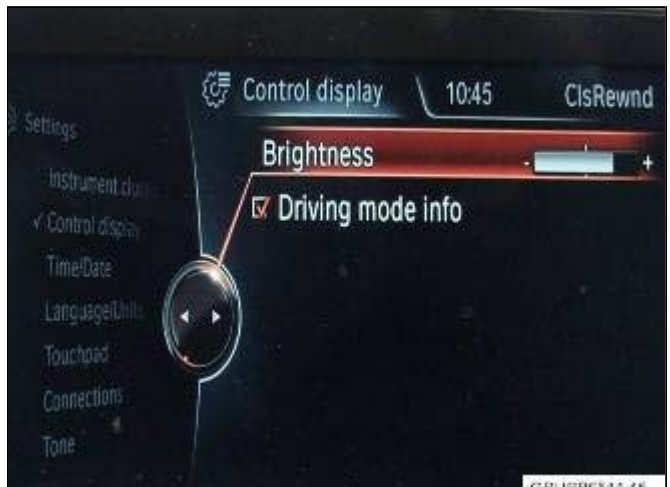
1. With the ignition turned on, check the brightness setting of the Central Information Display.

<ol style="list-style-type: none"> 2. In the Main Menu, select Settings > Control display. 3. When the display brightness is set to 60% or higher, reduce the brightness setting to 50% or below.
--	--

4. Retest the function of the CID.
5. When the CID **no longer dims** and/or flashes off/on, replace the HU-H head unit. Proceed with the procedure as described for Cause 1.
6. If the CID **still** dims and/or flashes off/on, replace the CID. Proceed with the procedure as described for Cause 2.
