SI M11 04 14  
Engine

August 2014  
Technical Service

**N16 Engine: Oil Leak from Cylinder Head Sealing Plug**

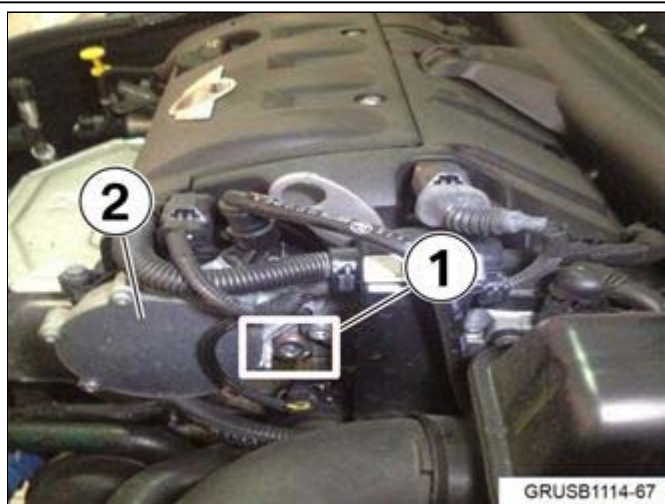
An oil leak can develop at a sealing plug located in the cylinder head, just below the vacuum pump.

1. Locate the sealing plug (1) near the vacuum pump (2).

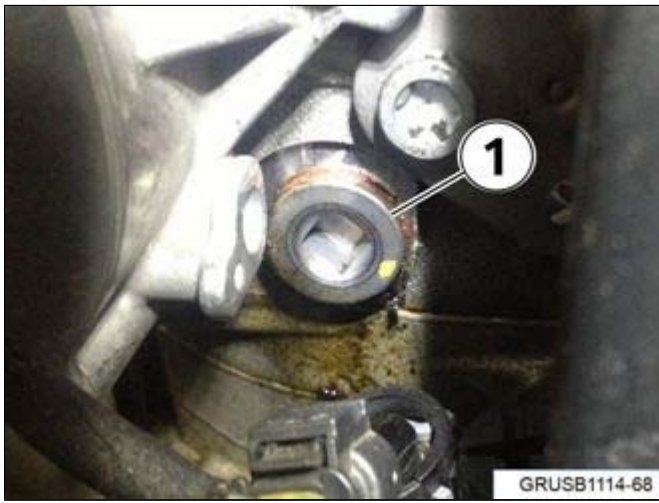
2. Clean the leaking area with a shop towel.

Use a spray solvent that is equivalent to brake cleaner to remove the remaining oil residue.  
Loosen the sealing plug and re-torque it to 40 Nm.
