| Bulletin # 61 002 13 (009)R | | | | | | |

## BMW Motorrad USA

### Service Information Bulletin

**Subject:** Chafing of wiring harness

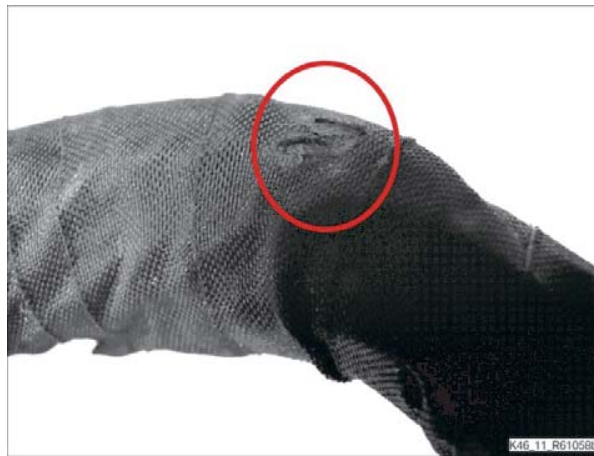
It is very important to examine the wiring harness closely at the points of contact; expose the wiring if necessary. Chafing often affects only very small areas.

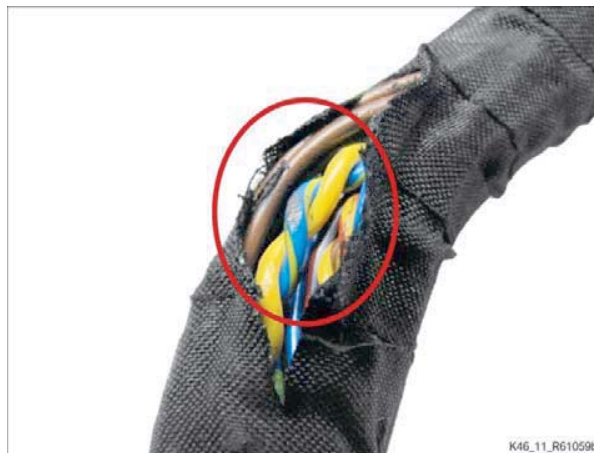
If the cable color cannot be identified at the chafing point: carefully open the wiring harness.  
If the color of the damaged wire for a component (component identification with the aid of the wiring diagram) and the fault symptom match, the cause has been found. If necessary continue the search for further chafing.

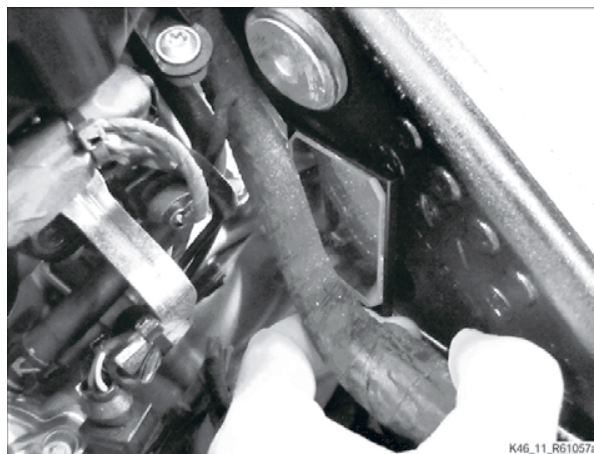
Use a mirror to examine the wiring in awkward locations (e.g. between intake silencer and frame).  
Remove the intake silencer if necessary for a close examination.

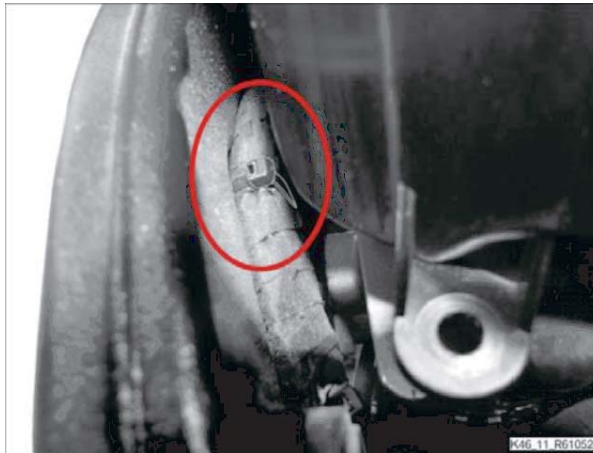
Chafing point on engine wiring harness (left side of vehicle)

In order to prevent the re-occurrence of chafing, wrap the area in question with several layers of genuine reinforced fabric adhesive tape (part number: 83 30 0 402 345) and pad it if necessary - **a length of tire inner tube can work well**.

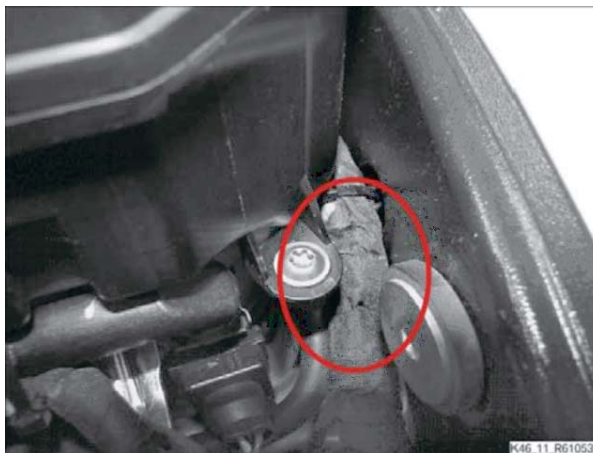
Chafing point on main wiring harness (right side of vehicle)

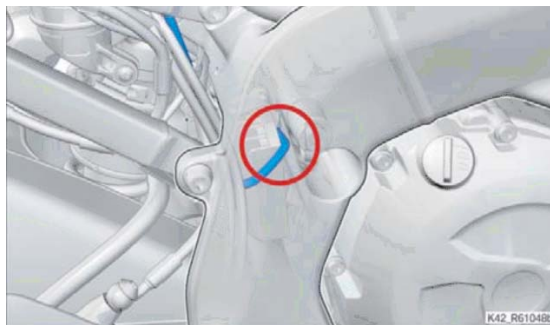
**HP4 (K42): Cable of the rear ride-height sensor chafes against regulator housing**

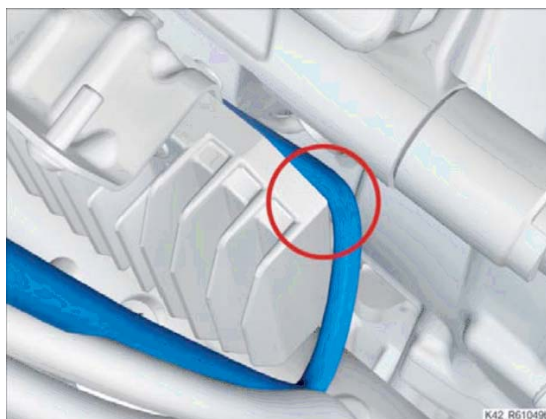
**Close up of HP4 (K42): Cable of the rear ride-height sensor chafes against regulator housing**
