Ticking Noise from Driveshaft During "Hard" Acceleration

F80 (M3 Sedan)

F82 (M4 Coupe)

F83 (M4 Convertible)

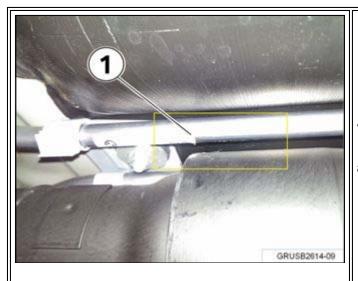
There must be a minimum distance of 10 mm between the parking-brake tube and the driveshaft (1).
