This Service Information bulletin supersedes SI B65 16 14 **dated August 2014**.

Central Information Display Intermittently Dimming or Flashing Off/On

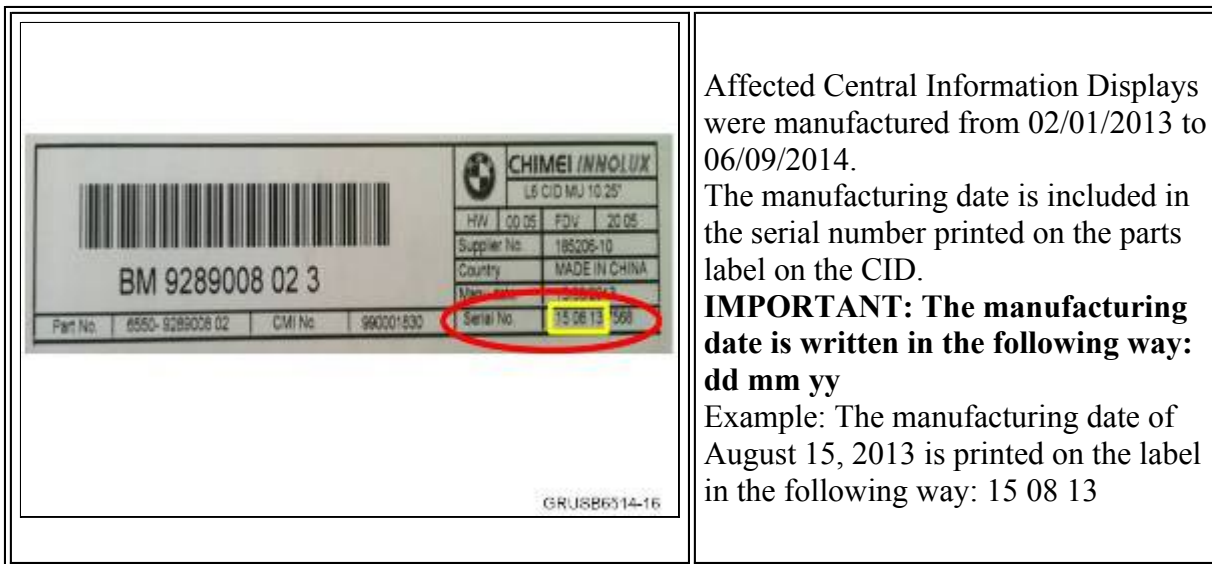
Affected Central Information Displays were manufactured from 02/01/2013 to 06/09/2014.

The manufacturing date is included in the serial number printed on the parts label on the CID.

IMPORTANT: The manufacturing date is written in the following way: dd mm yy

Example: The manufacturing date of August 15, 2013 is printed on the label in the following way: 15 08 13

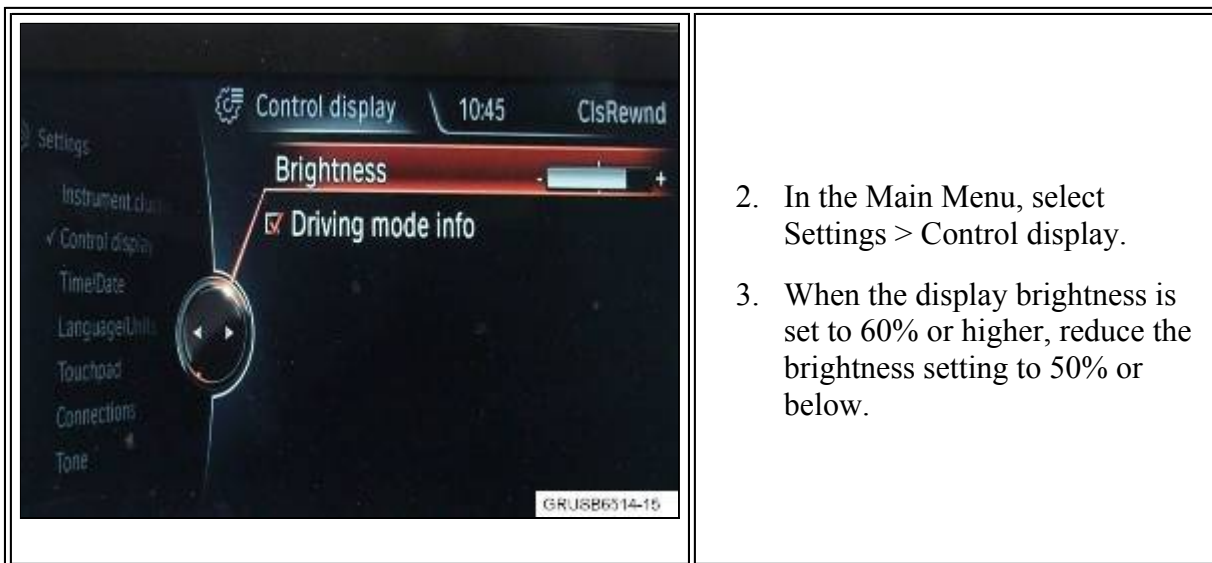
1. With the ignition turned on, check the brightness setting of the Central Information Display.

2. In the Main Menu, select Settings > Control display.
3. When the display brightness is set to 60% or higher, reduce the brightness setting to 50% or below.

4. Retest the function of the CID.
5. When the CID **no longer dims** and/or flashes off/on, replace the HU-H head unit. Proceed with the procedure as described for Cause 1.
6. If the CID **still** dims and/or flashes off/on, replace the CID. Proceed with the procedure as described for Cause 2.
