This Service Information bulletin supersedes SI M11 04 14 dated August 2014.

N16 Engine: Oil Leak from Cylinder Head Sealing Plug

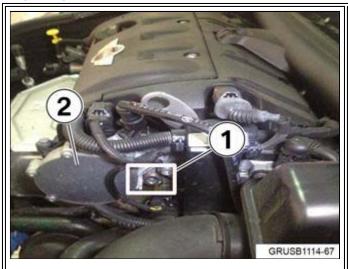
An oil leak can develop at a sealing plug located in the cylinder head, just below the vacuum pump.

The sealing plug was not tightened sufficiently during production.

1. Locate the sealing plug (1) near the vacuum pump (2).
