This Service Information bulletin supersedes SI M51 04 14 **dated May 2014**.

Driver's Side Exterior Door Handle Cover Cap Is Loose

F56 (Cooper, Cooper S)

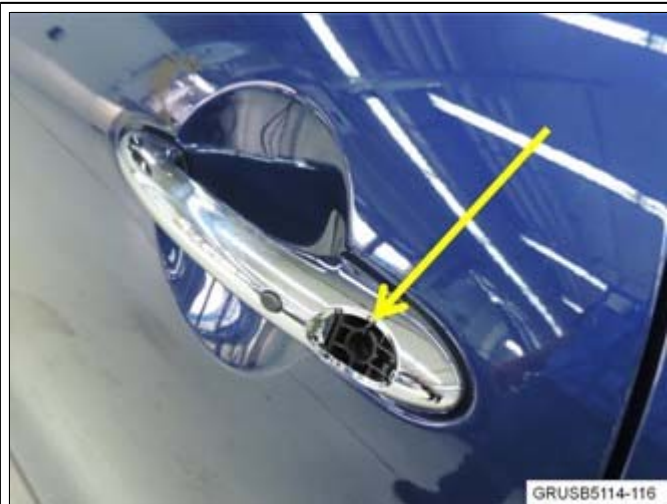
The driver's side exterior door handle cover cap is loose or missing.

Driver's side exterior door handle

1. The driver's side exterior door handle cover cap is loose or missing.

Replace the driver's side exterior door handle.
