## BMW Motorrad USA

### Service Information Bulletin

### **\*\*Technical Campaign\*\***

**Subject:** Multifunction Switch

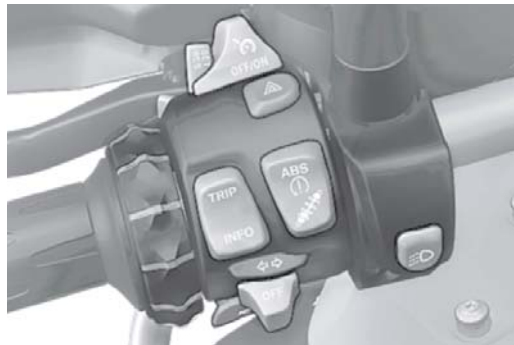
**Details:** Within the framework of quality monitoring, BMW Motorrad has ascertained that the multifunction switches fitted to the above models might be faulty. This can result in failure of certain functions or situations in which functions can no longer be cancelled.

Illustration: Multifunction switch with one-button operation of the turn indicators

**Aftersales Solution:** When a motorcycle that is affected by this issue is brought to the workshop, replace both (left and right) multifunction switches. See the current EPC/ETK for parts and RSD (Repair and Service Data BMW Motorrad) DVD for a description of the appropriate model / option repair item.
