US 54380454-02

Rattling noises from timing gear

**Vehicles affected****E series**

K42 K46 K46/11 K47

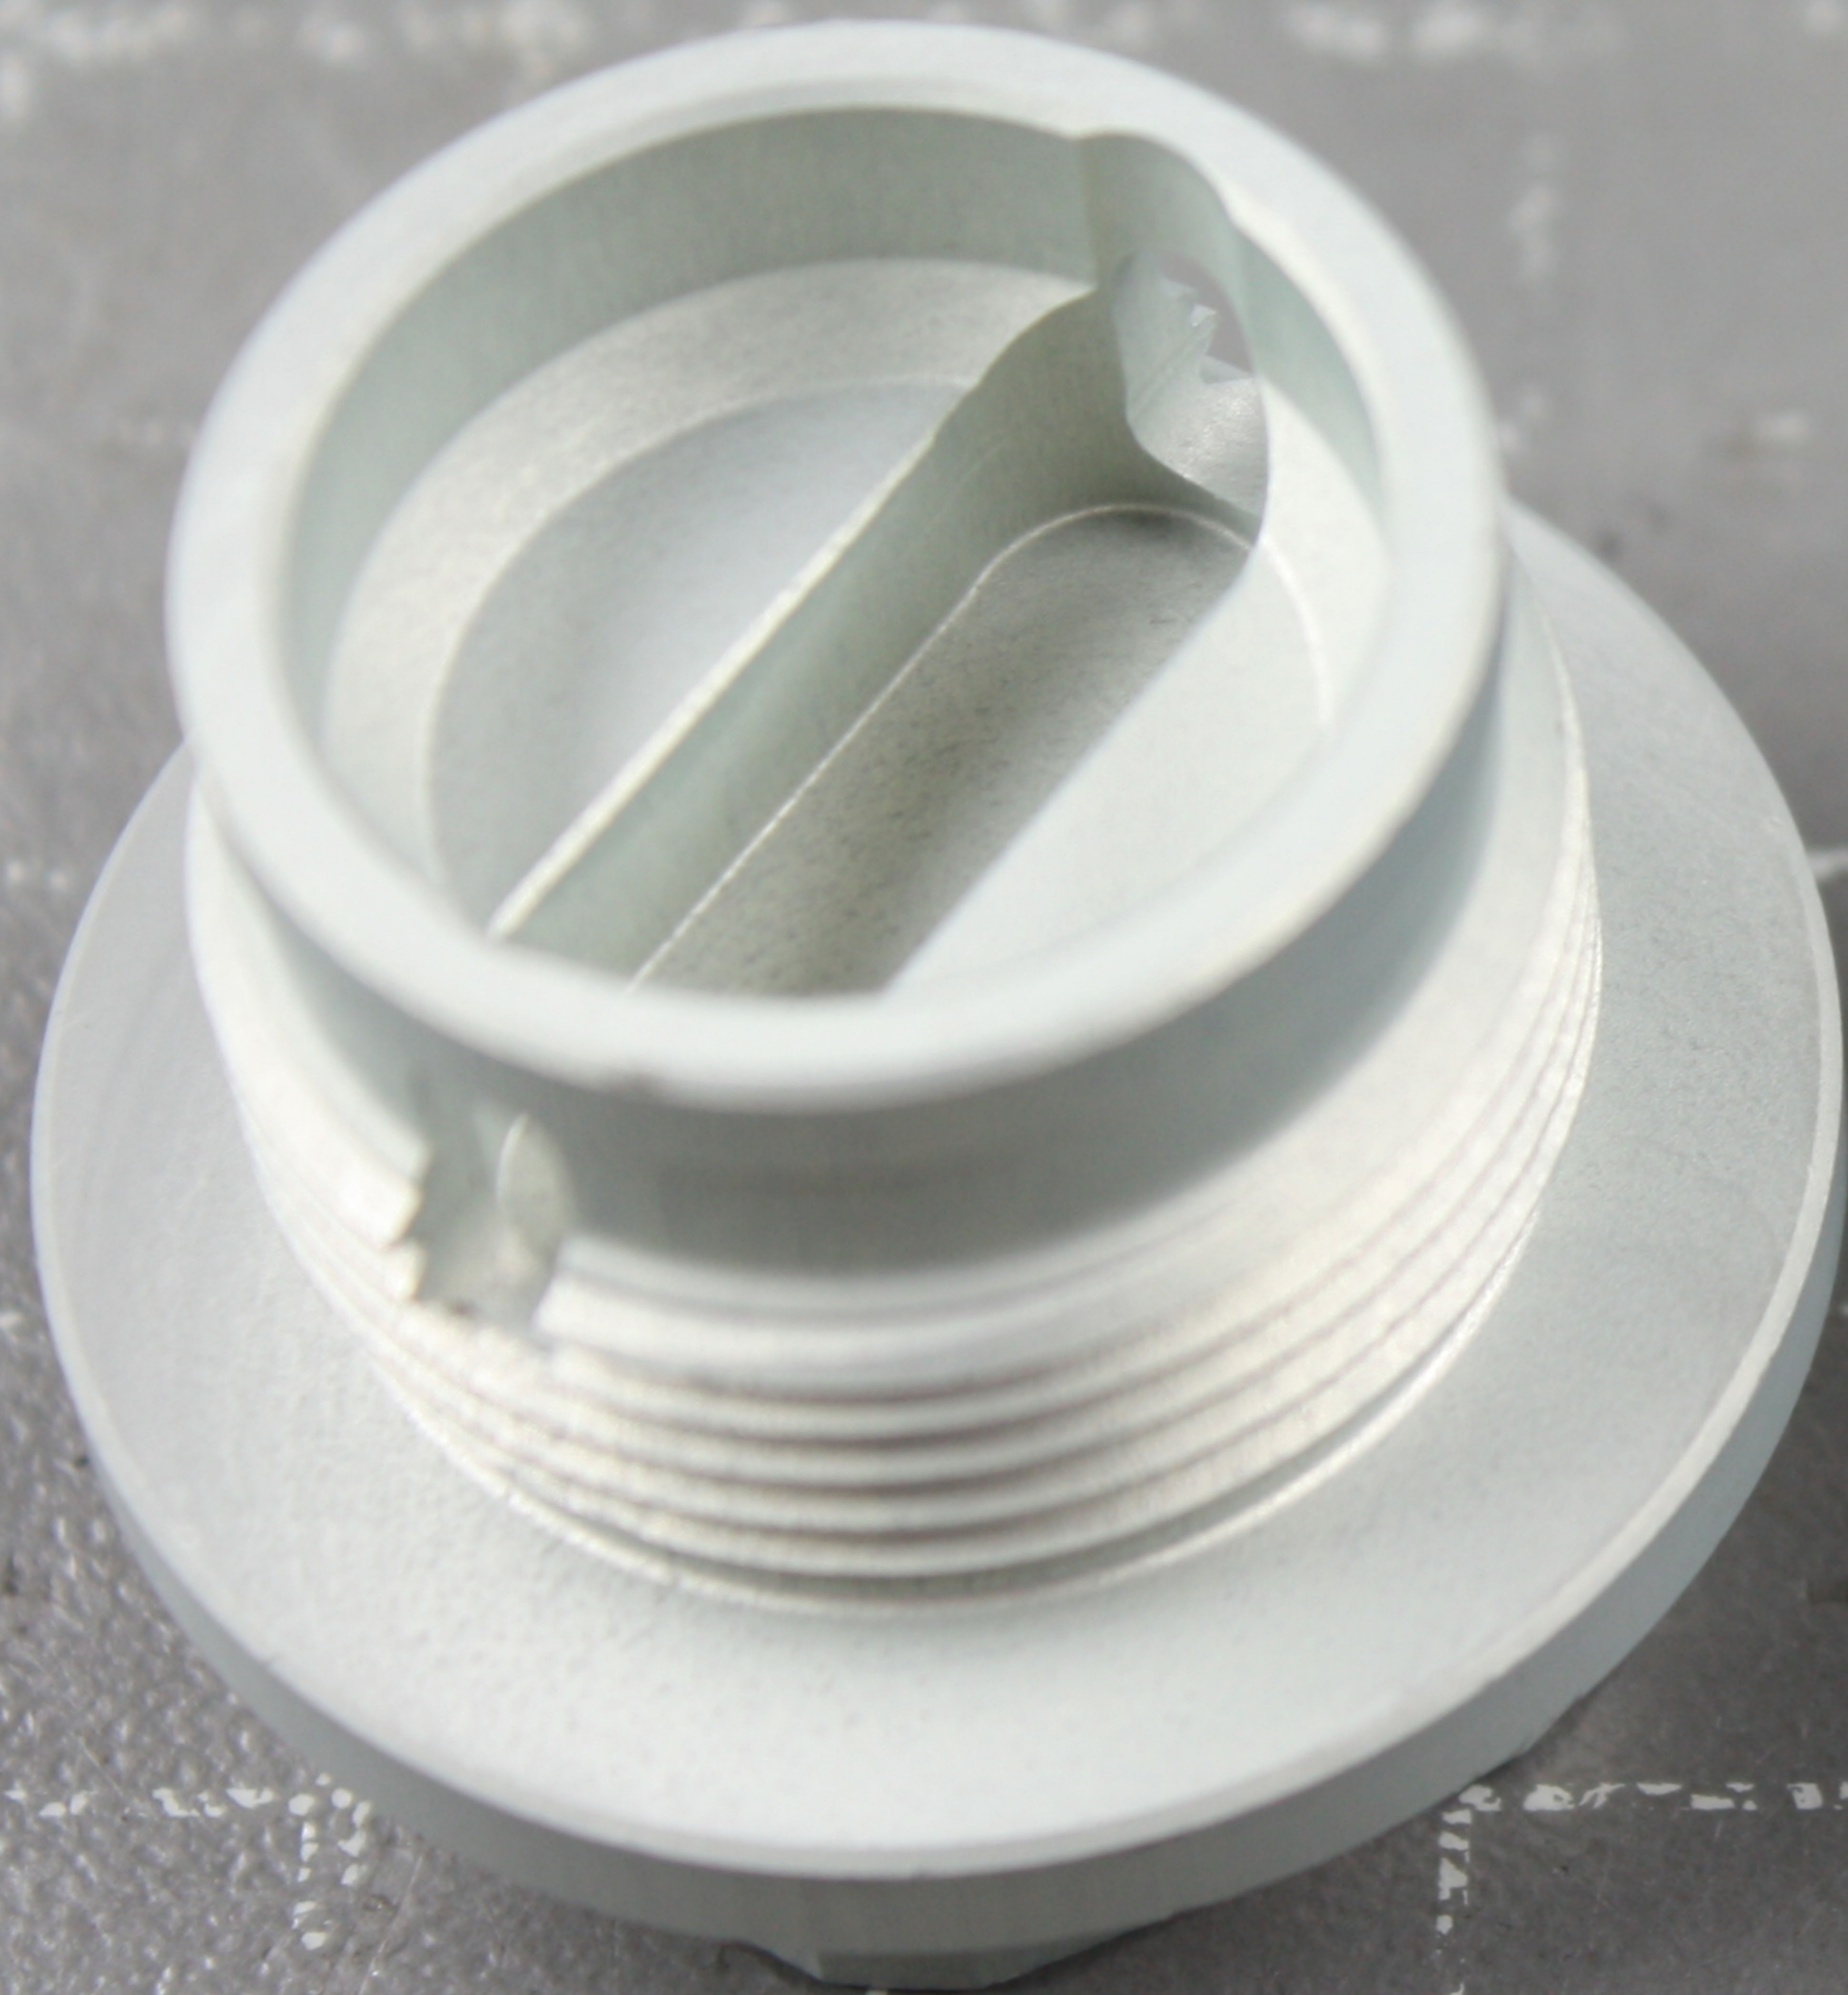
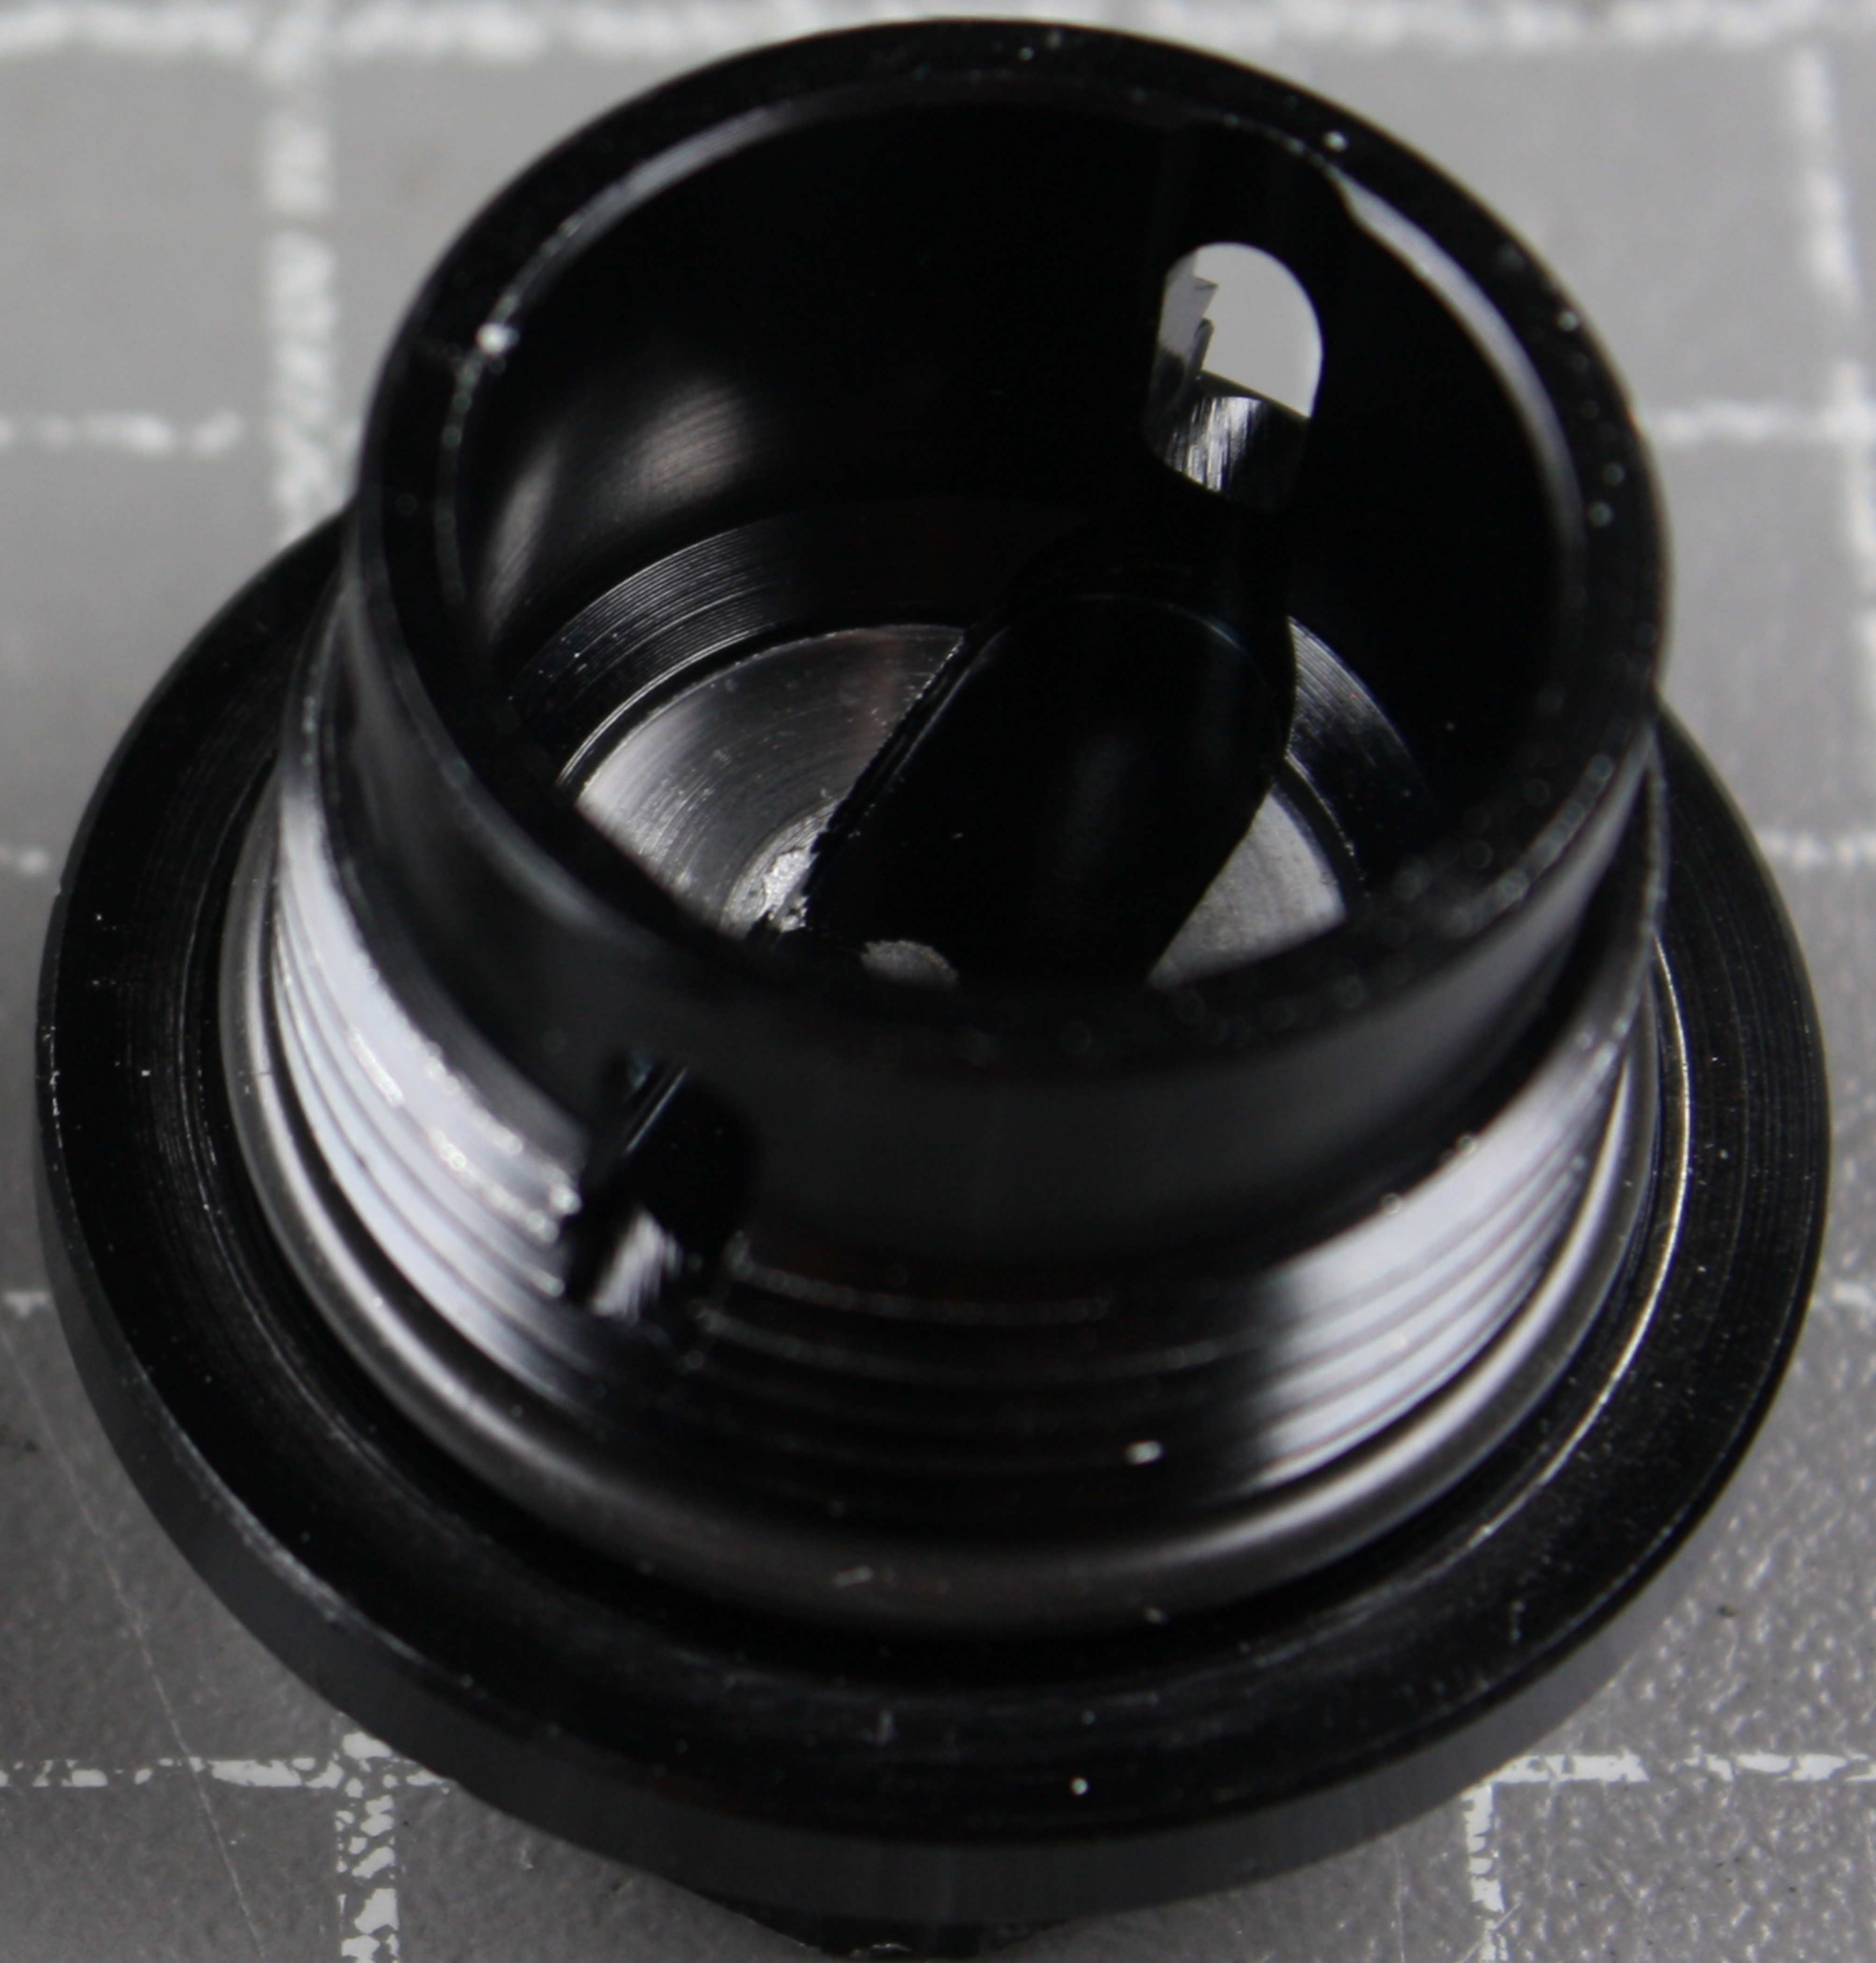
After approximately 18,000 mi, the timing chain ( 11 31 7 713 828) may wear to the point that the chain tensioners range of adjustment is no longer sufficient to accommodate the change in length.

In the event of a verified customer complaint, remove the black screw plug (11 31 7 718 069) and replace it with a silver screw plug (11 31 8 534 849).

See attached photo.

Note; The silver screw plug has a longer range of adjustment for the chain tensioner and installing it in conjunction with a new timing chain or one that does not exhibit signs of wear is not permitted.
