**NEW** N51 Engine: Service Engine Soon Lamp Illuminated - Loss of Power and Various Faults Stored in the DME

E82 (1 Series Coupe)

E90 (3 Series Sedan)

All vehicles produced to 6/2011

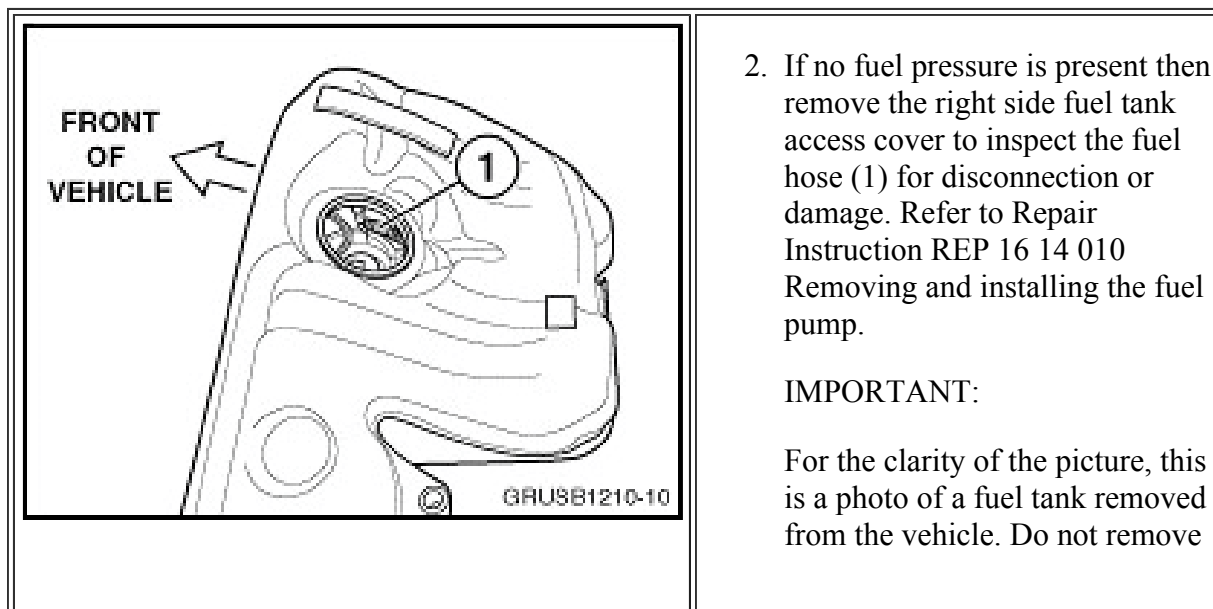
2. If no fuel pressure is present then remove the right side fuel tank access cover to inspect the fuel hose (1) for disconnection or damage. Refer to Repair Instruction REP 16 14 010 Removing and installing the fuel pump.

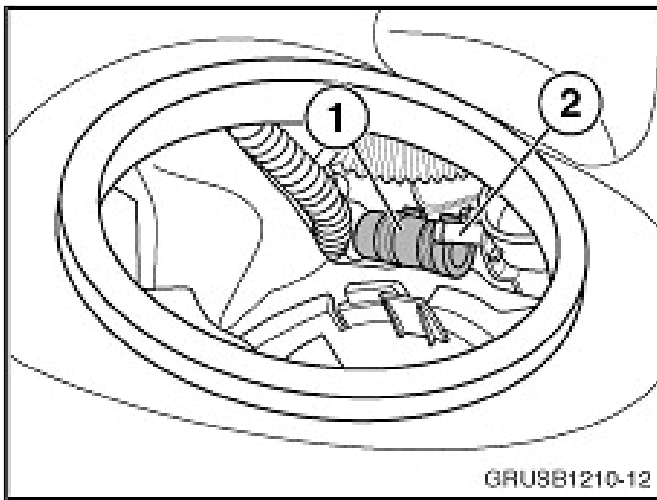
The vehicle has lost fuel system delivery pressure due to a loose or split fuel line inside the fuel tank. The failure is related to an unfavorable stacking of tolerances between the rubber fuel hose and the plastic regulator nipple or deterioration of the rubber hose construction material.

3. Inspect the fuel hose connection (1) on the pressure regulator (2). If the fuel hose is found to be disconnected from the fuel pressure regulator, replace the fuel tank. Do not attempt to replace or re-secure the fuel hose inside the fuel tank.

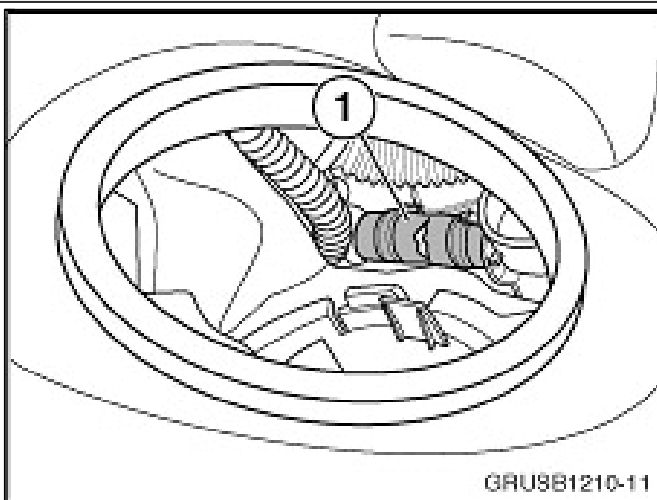
4. Inspect the fuel hose (1) for splitting. It might be necessary to inspect the entire circumference of the fuel hose with a small mirror. If the fuel hose (1) is found to be split, replace the fuel tank. Do not attempt to replace or re-secure the fuel hose inside the fuel tank.
