This Service Information bulletin supersedes SI B17 01 14 **dated May 2014**.

**Low Coolant Level with No Sign of External Leaks**

F30 (3 Series Sedan)

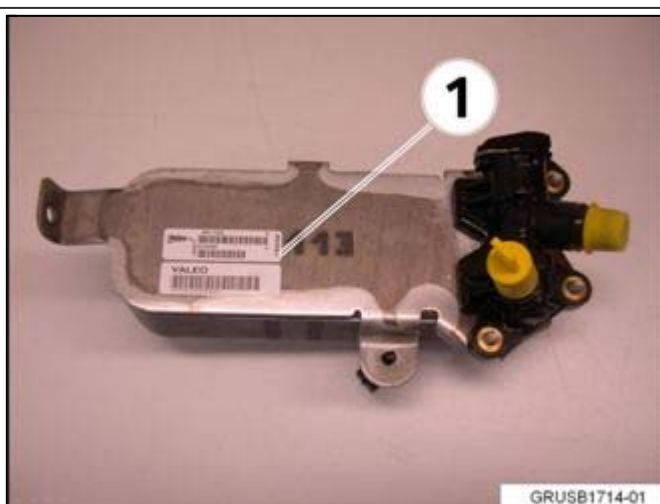
Access the cooler and visually check the parts label on the coolant side of the cooler (1).

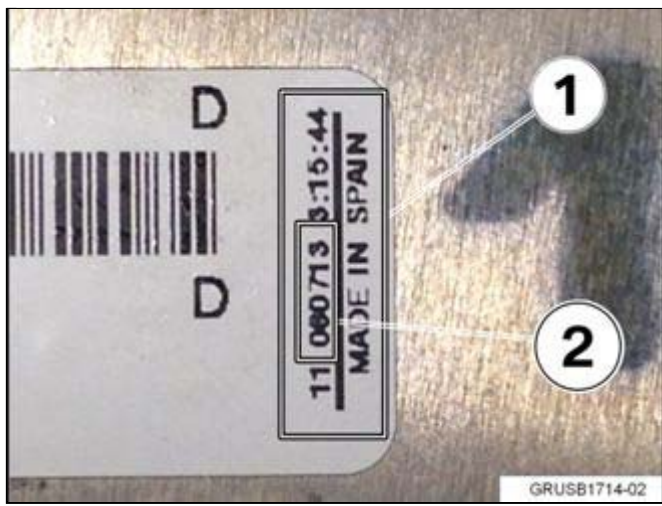
Defective coolers are labeled “Made in Spain” (1) and the production range is

06.06.2013 to 04.08.2013  
(DD/MM/YY) (2).

Once the transmission oil cooler has been determined to be faulty, the cooler and automatic transmission must be replaced. The cooler lines must be properly flushed to remove any remaining contaminants (coolant/oil mix).

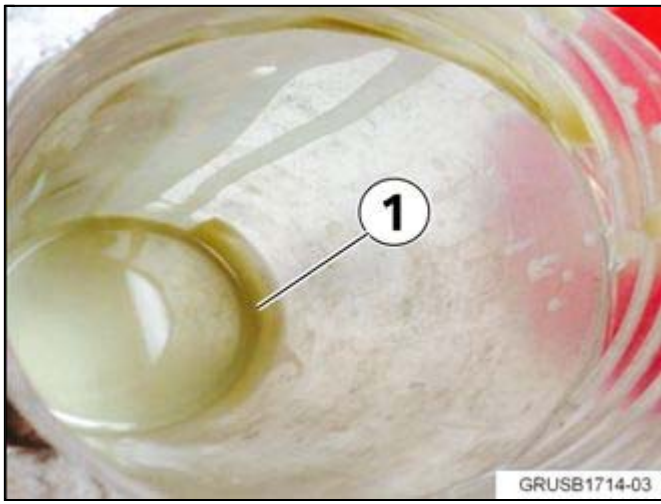
Drain a small amount of transmission fluid (at the transmission heat exchanger) to inspect for coolant contamination. Contaminated fluid will have a milky color (1). Submit a PuMA Info Only case titled "F30 Transmission Oil Cooler" if there is any concern about the color or condition of the fluid.

TC PuMA Case approval is still needed for replacement of the transmission (refer to [SI B24 05 12](#)). Provide pictures of the fluid with the Case if there is any concern about the color or condition of the fluid.
