Service Action: Retorque Stiffening Plate Bolts on Front and Rear Axle

I12 (i8)

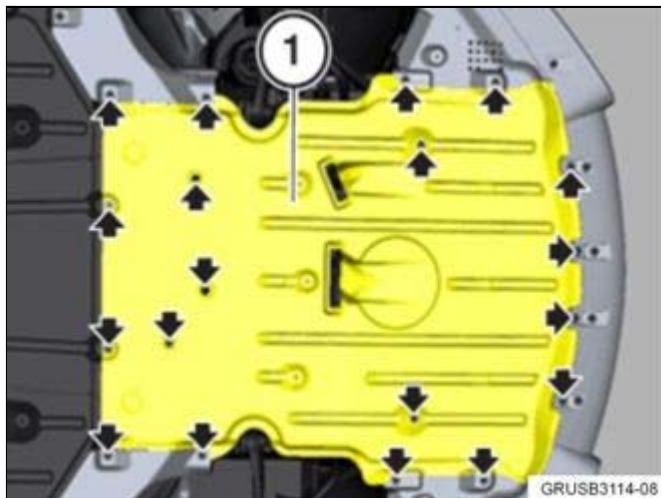
Front stiffening plate

On the front and rear axle stiffening plate bolts, the intended tightening torque may not have been reached during assembly.

Remove the front underbody protection per RA 51 47 490, "Removing and installing/replacing underbody protection (front)."

- Release the screws (arrows).
- Remove the underbody protection.
- Reinstall torque screws to:
 - No metric head, 3 Nm
 - With metric head, 5 Nm

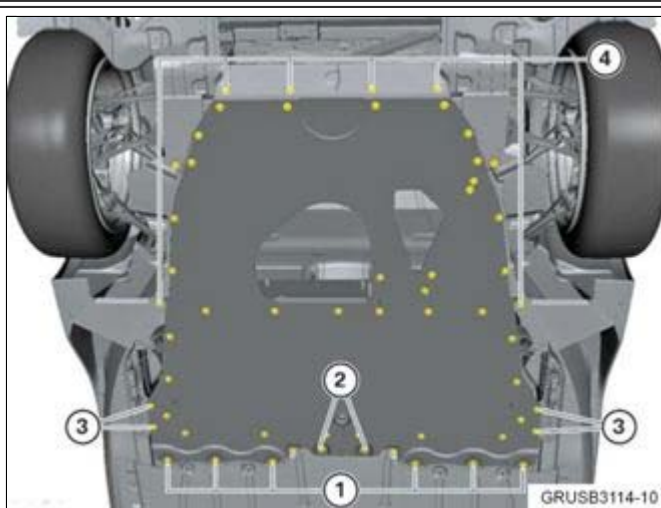
Rear stiffening plate

All bolts in the illustration numbered 1, 2, 3, and 4 are NOT to be retorqued!

Retorque all bolts M8x21 (Torx T50). Loosen them one by one (approx. 45 degrees) and retorque one by one to 28 Nm.

Note: Loosen and retorque each screw before starting the next one.
