**Service Action: Install Missing Underbody Seals**

F83 (M4 Convertible)

Produced from July 9, 2014 to September 3, 2014

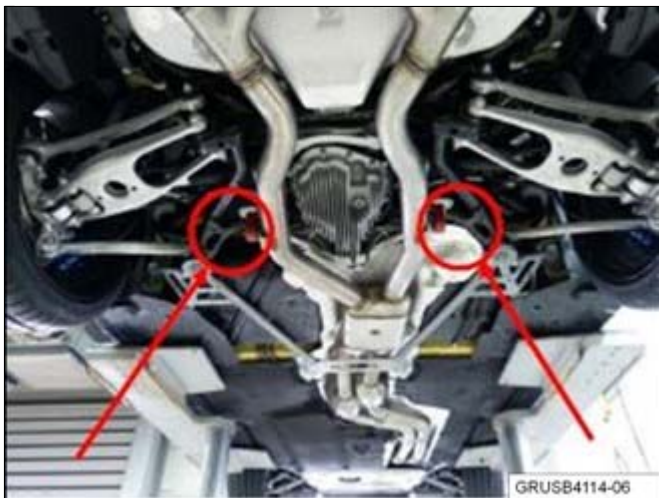
Two unused underbody threaded holes have not been sealed.

Sealing pads were not installed at the factory.

1. Locate the two threaded holes in the underbody which are missing the pads.
