Charging Concerns

I01 (i3 and i3 REx)

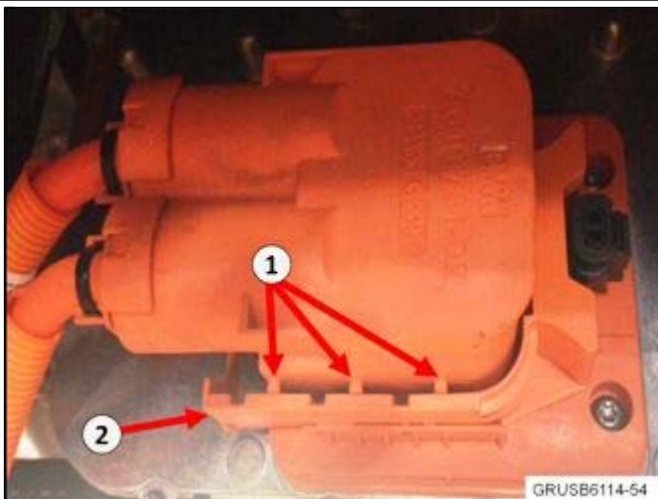
Inspect all HV connectors on the KLE for proper fit. It is possible that one of the HV connectors on the KLE is not seated fully, and in some cases, might not be connected at all.

Note: Pay special attention to the locking tabs (1) on the connector to make sure they are fully seated in the sliding connector lock (2). When fully seated, the tabs are not visible.

In the image, the locking tabs are not seated, causing the connector sliding lock to bow and prevent it from locking on the connector.

If a KLE connector is found to be loose or not connected, inspect the connector and the KLE for damage to the connectors, damage to the contacts, or overheating.

If any damage or overheating is found, replace the affected HV cable and KLE.

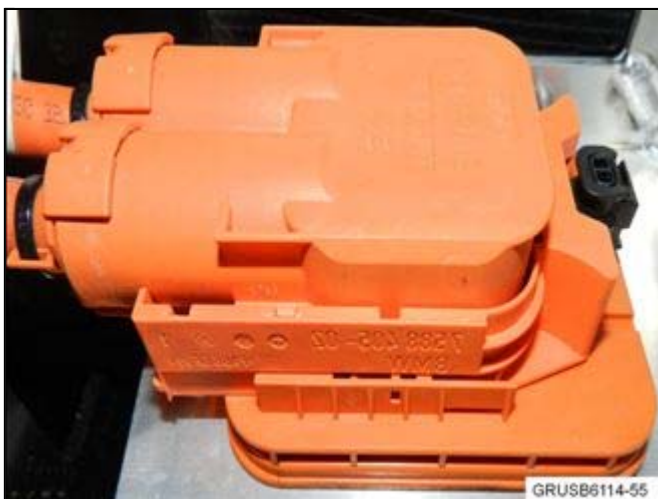
This image shows an HV connector that is properly seated and locked in place correctly.
