Service Action: Replace Instrument Cluster

F30 (3 Series Sedan)

The display in the instrument cluster is inoperative.

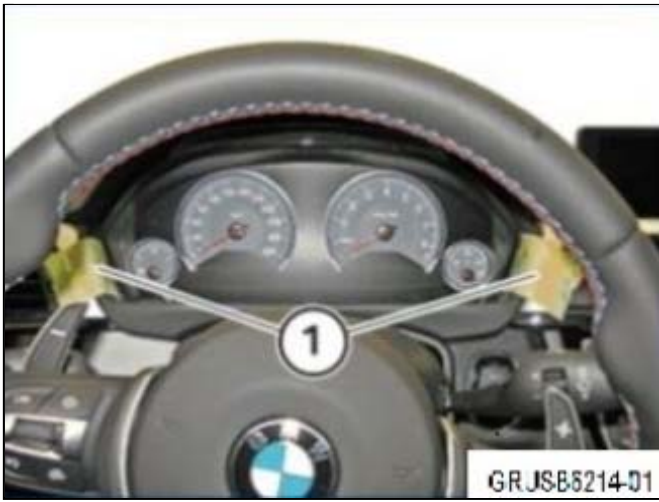
4. In order to prevent damage, plastic adhesive tape (1) must be stuck on the left and right side of the instrument cluster.

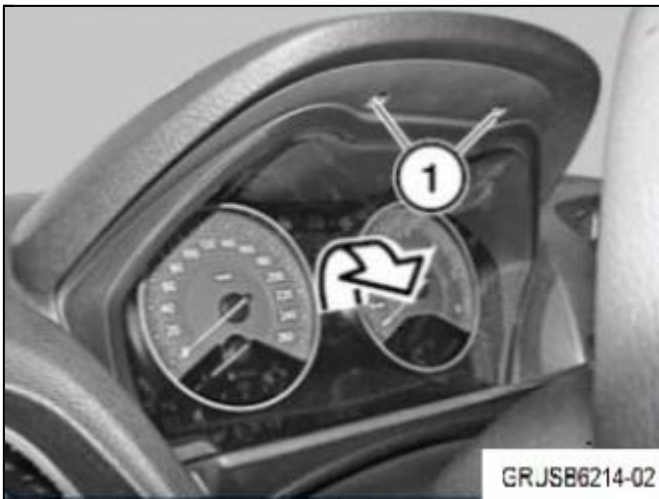
5. Release the screws (1).
6. Pull out the instrument panel in the direction of the arrow.

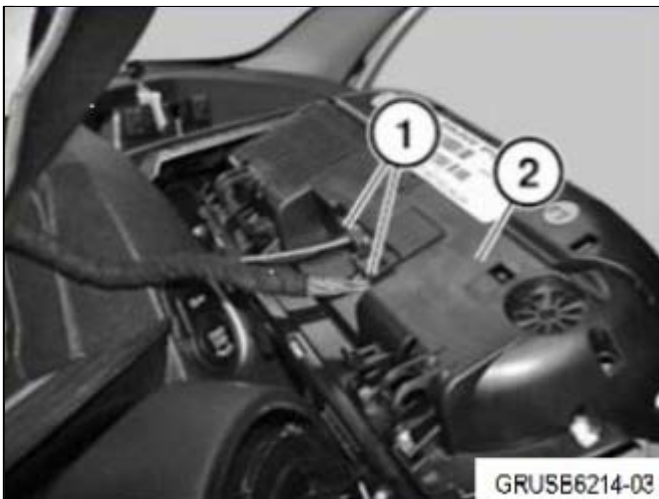
7. Unplug the two connectors (1) and remove the instrument cluster (2).

8. Install the new instrument cluster.

NOTE: The retaining tabs (1) of the instrument cluster (2) must be exactly seated in the dashboard mountings. Follow the instructions in the reverse order to install the instrument cluster.

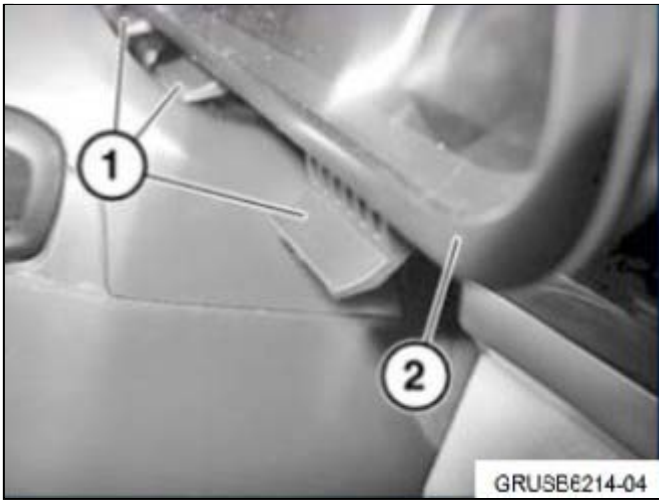
9. Tighten the screws on top of the instrument cluster housing when it is in place.

Tightening torque: 1.5 Nm (+/- 0.3 Nm)

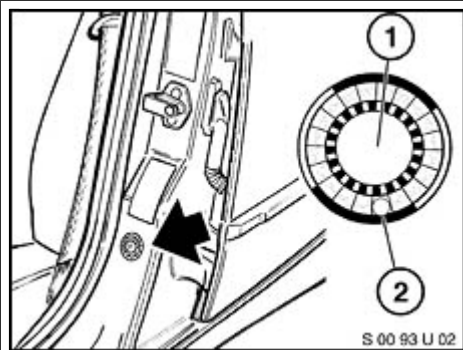
This Service Action has been assigned code number **710**. After the vehicle has been checked and/or corrected, obtain a label (SD 92-453) and:

- Emboss your BMW center warranty number in the middle of the label (1);
- Punch out code number **710** (2), printed on the label; and
- Affix the label to the B-pillar as shown.
