**SUBJECT****LED Headlight Malfunction****MODEL**

F15 (X5)

Vehicles produced to September 2014

With option 552 (Adaptive LED headlight)

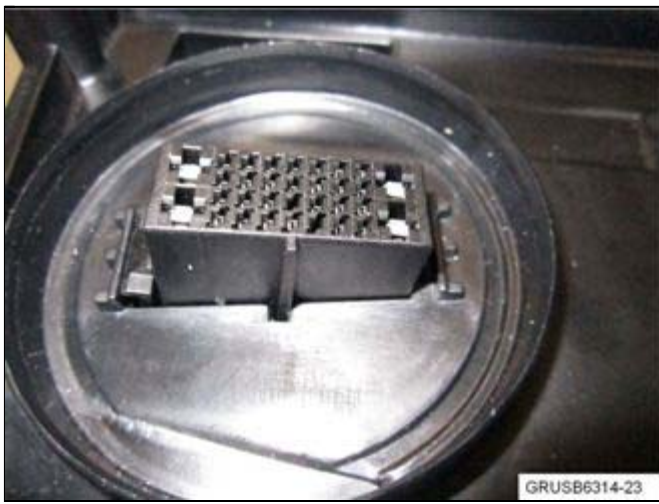
The situation above is caused by a poor connection at the LED headlight connector or LED main light module.

5. After removing the LED main light module, push down on the connector.
6. If the connector is pushed down as shown in the picture, continue to the next step.
