**SUBJECT****Front Axle Brake Pad Wear Sensor Routing****MODEL**

F56 (Cooper Hardtop)

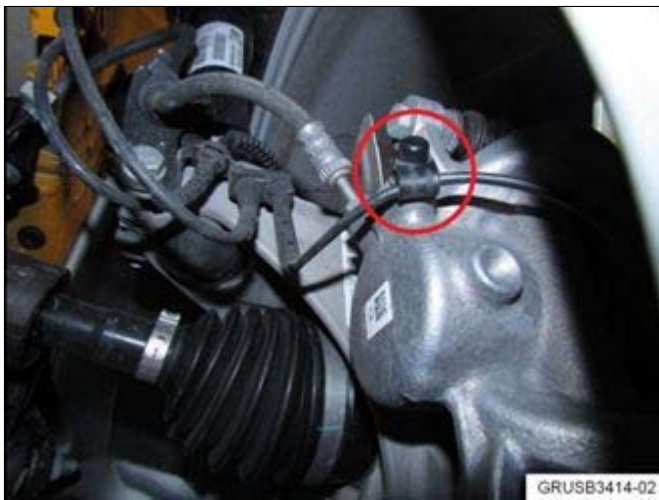
During brake service, the brake pad wear sensor cable may be incorrectly routed and also fastened to the front brake caliper's bleed valve dust cap. Incorrect routing of the brake sensor cable may cause damage to the cable or brake sensor, resulting in a brake warning message being displayed.
