| Measure no. | Subject | |
| US 47293307-02 | Electronic throttle grip fault code memory entries | |

#### Vehicles affected

| E series | Engine | Body |
|---|---|---|
| K48 | 6-ZYL | |

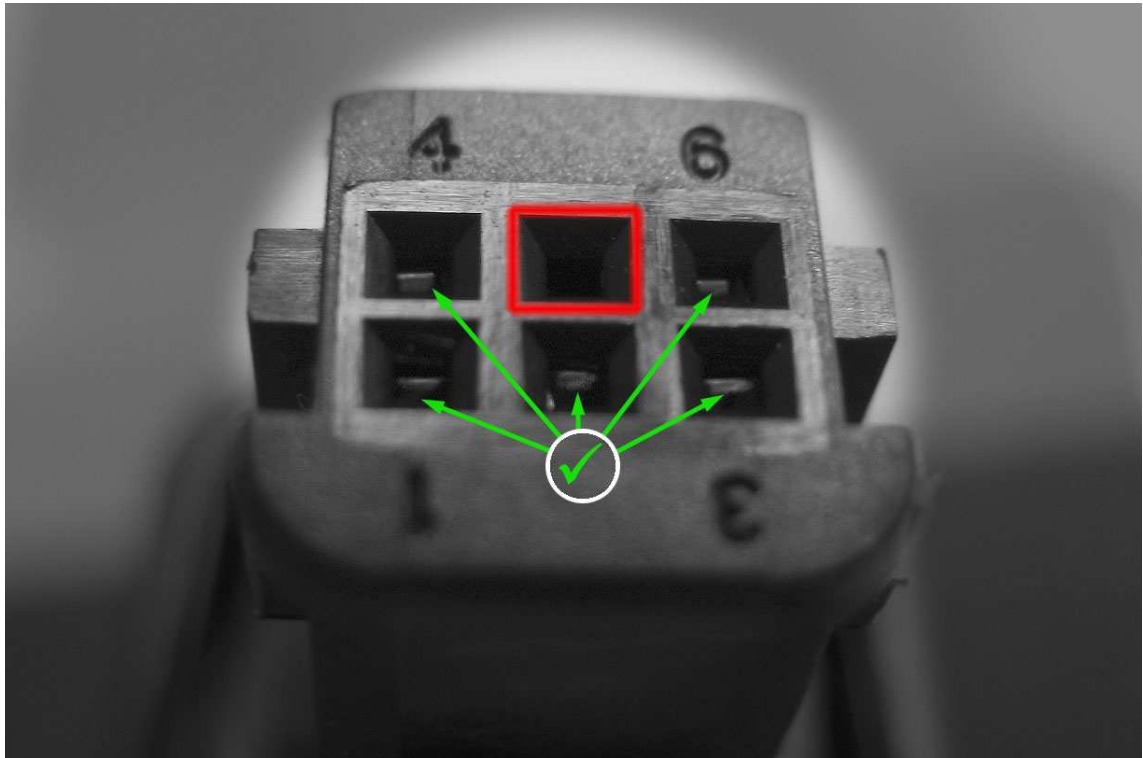
Picture 2

1. Undo the housing lock at the top and bottom, grip and pull off (picture 1).
2. Check the position of the contacts in the housing using an illuminated magnifying glass. Look into the chambers from the front, at an angle. Correctly seated contacts are visible (picture 2 - in this example, the contact in chamber 5 is not visible, i.e. not in the correct position).
3. Carefully release the protective cap on the cable side/wire harness and remove it (circled in red in pictures 1 and 3).
4. To move the contact to its correct position. Use a suitable tool (small, clean screwdriver), carefully open the secondary lock (picture 4). Open the secondary lock only slightly, so that it does not break (picture 5).
