Service Bulletin

Bulletin No.: P11325

Subject: Instrument Cluster Goes Blank, Lights Turn On and Off, Gauge Pointers Drop, Bluetooth Pairing Issues

Models: 2014 Chevrolet Silverado 1500
2014 GMC Sierra 1500

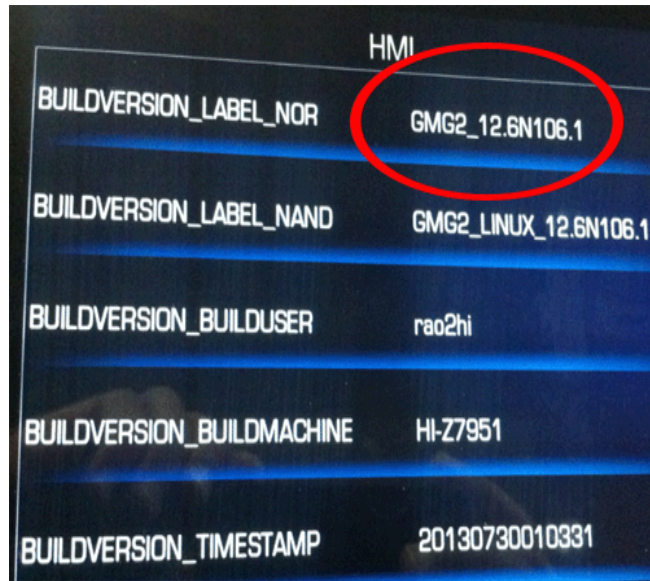
3749596

Before updating software, check the HMI (Human Machine Interface) build version. The HMI build version label should be GMG2.12.6N106.1 or earlier.

Caution: If the software version is later than GMG2.12.6N106.1, damage to the HMI module may occur. DO NOT PROCEED WITH THIS PI.

To verify the HMI build version, on the radio push the following button combination together (see below), then select HMI from the onboard development screen.
