Service Bulletin

Bulletin No.: 06-03-09-004F

Subject: Squeak Noise from Rear of Vehicle (Lubricate Rear Leaf Springs)

Models: 1999-2007 Chevrolet Silverado (Classic)
2007-2012 Chevrolet Colorado
2007-2015 Chevrolet Silverado
1999-2007 GMC Sierra (Classic)
2007-2012 GMC Canyon
2007-2015 GMC Sierra
2007-2010 HUMMER H3, H3T

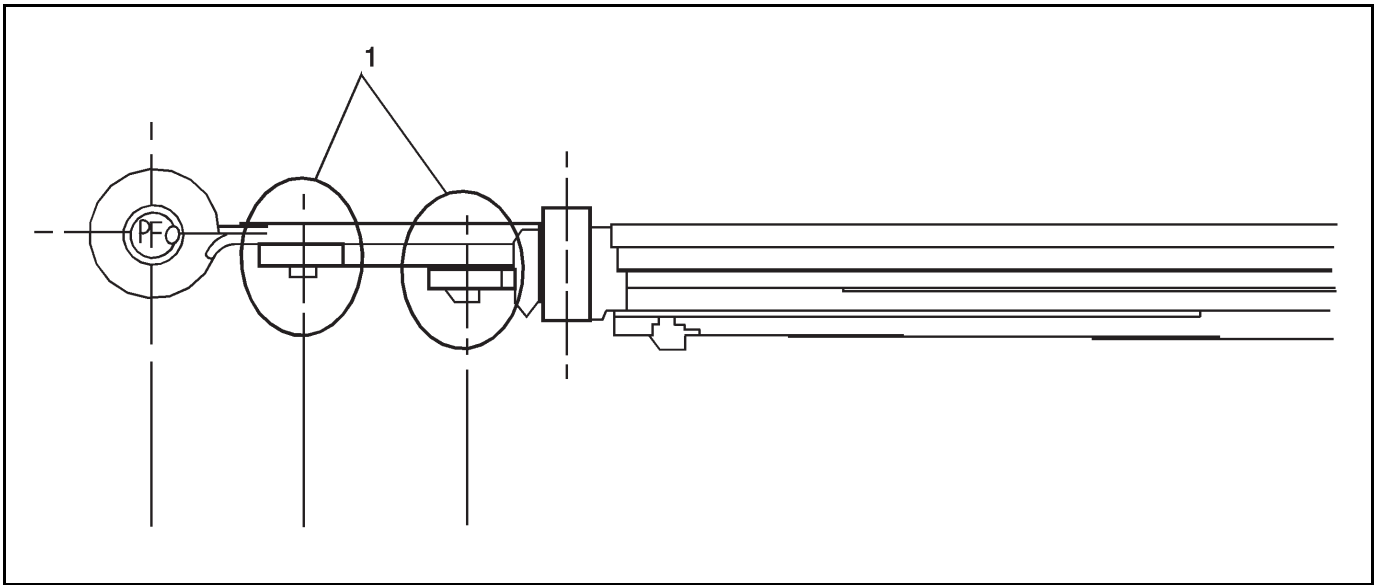
1826776

Some customers may comment about a squeak noise coming from the rear of the vehicle. During normal operation, certain vehicles may exhibit a squeaking noise that may be traced to the rear leaf springs. While this noise is an operating characteristic of leaf springs, the frequency and severity of this noise will be affected by the roads that the vehicle is driven on.

This condition may be due to debris getting between the leaf springs.

Note: Ensure any tool used to gently pry the tip inserts or spring leaves is protected to prevent damage to the spring leaves.

5. Apply a liberal amount of grease, P/N 12345996 (in Canada, use P/N 10953501), both underneath and on top of the front and rear tip inserts for the #2 and #3 leaves, as indicated below. A screwdriver can be used to gently pry up the tip insert; however, a rag around the screwdriver must be used to prevent damage to the spring. Use a flat-bladed tool, such as a gasket scraper to properly distribute the grease.
6. Lower the vehicle to the ground and test drive to verify the repair.
