TT7484EN
April, 2014
Page 1 of 3

SUBJECT: Inability to Check Oil Level via Pushbutton Shift Selector on Kenworth and Peterbilt Trucks

MODELS AFFECTED: 3000 Series and 4000 Series Product Family Transmissions

VOCATIONS AFFECTED: Kenworth Models T680 and T880 and Peterbilt Models 579 and 567

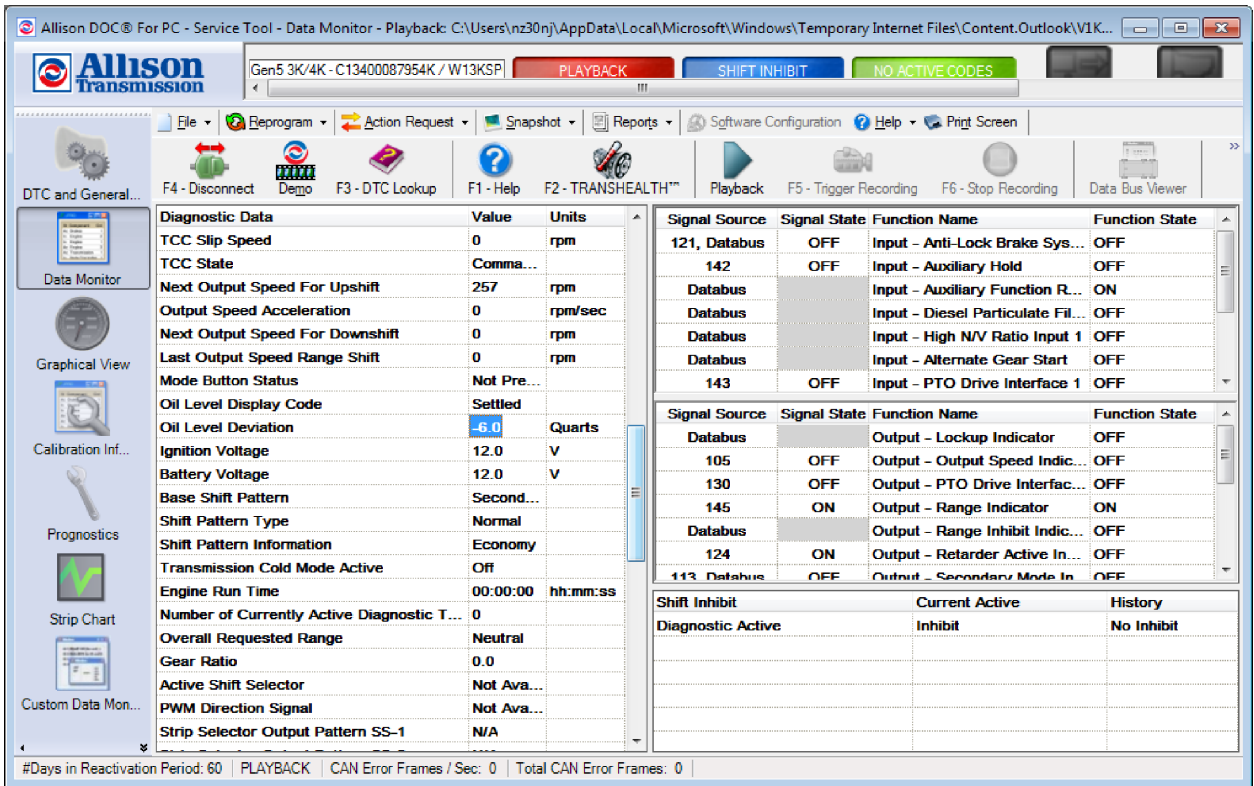
Figure 1. Oil Level Deviation Reading

The Kenworth and Peterbilt models listed above have been built without a wire for the oil level sensor (OLS) in a portion of the OEM harness. Wire 116 may be present from the transmission to a bulkhead connector, but it may be missing on the other side of the bulkhead.

- Inability to check oil level using the Pushbutton Shift Selector (skips to Prognostics).
- Very low (e.g. -6.0 Quarts) or no oil reading for "Oil Level Deviation" in the Data Monitor tab of the Universal Allison DOC® service tool. Refer to [Figure 1](#).

If an Allison customer brings their vehicle to your shop with complaint of this issue, or if this issue is discovered while performing customer maintenance or repair, please inform the customer that he or she should schedule an appointment with a Kenworth or Peterbilt dealer to address the issue.

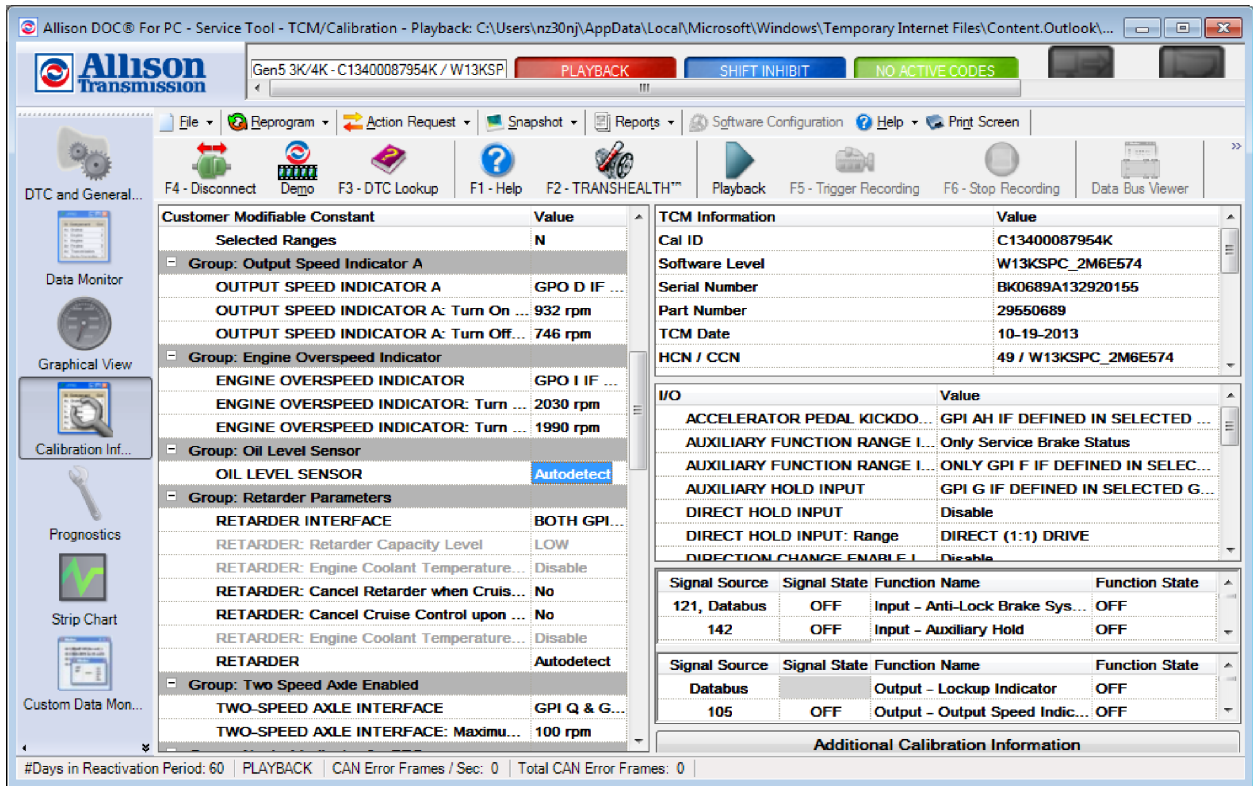
Figure 2. Oil Level Sensor Parameter

NOTE: When viewing the Calibration Information screen in the Universal Allison DOC® service tool software, the OIL LEVEL SENSOR parameter will still show “AUTODETECT”. Refer to [Figure 2](#).
