Side windows may make noises when closing and opening, or reverse direction when closing.

Topic number	LI67.30-P-055417
Version	4
Design group	67.30 Side windows
Date	07-08-2014
Validity	MODEL 166.8 Up to VIN end no.: L003467 Up to VIN end no.: M 003467 Up to VIN end no.: A 361392
Reason for change	Part number changed. Repair procedure changed.
Reason for block

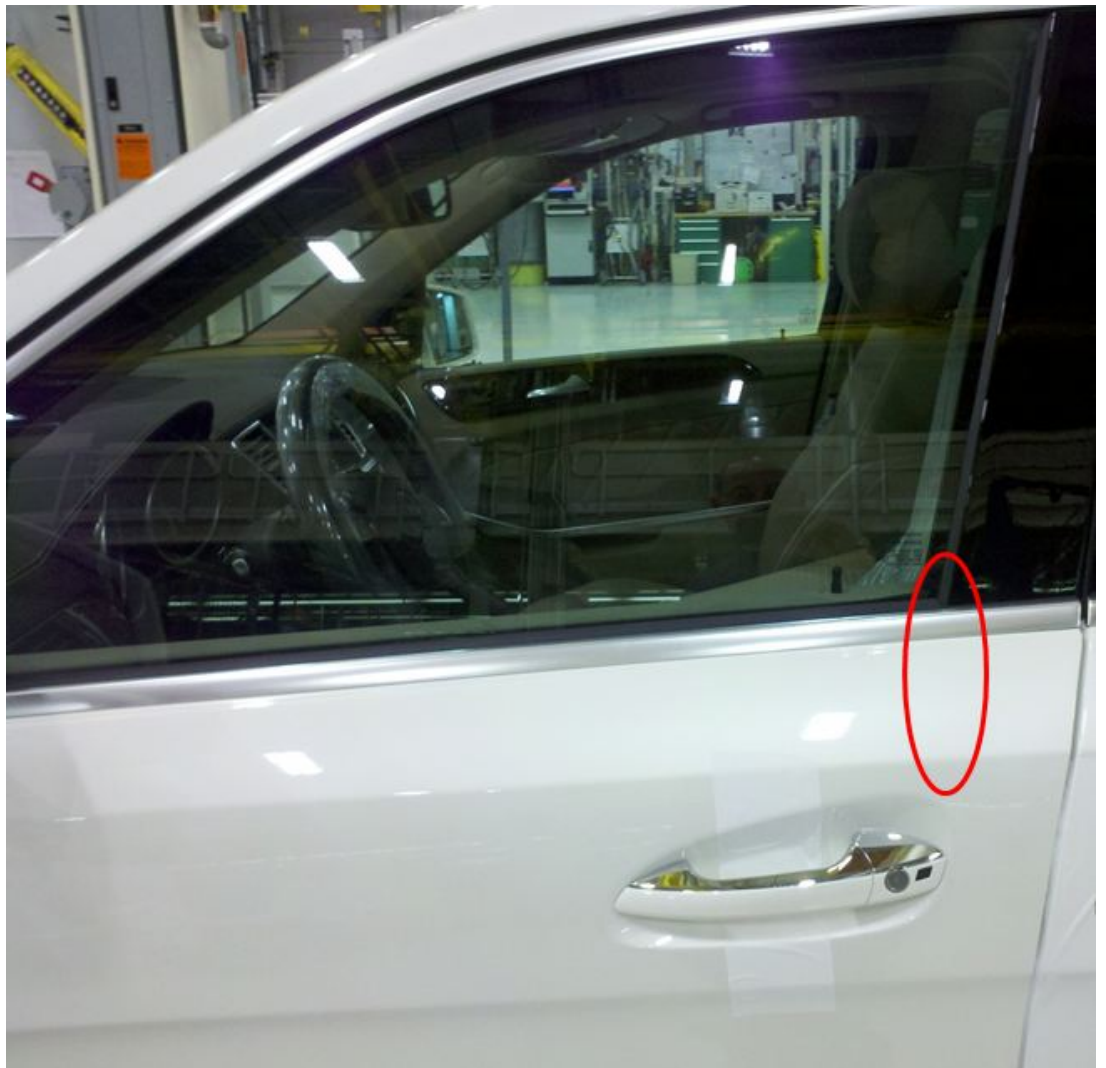
Bild 1.JPG:

On the front doors the lip may be folded over on the window guide rail below the beltline in the area of the B-pillar (see Pictures 1 and 2).

Consequence: Friction is too high and leads to noises.

Visually inspect whether the lip is folded over on the window guide rail.

- To do this, remove beltline trim strip.
- If the lip is folded over, the window guide rail must be replaced.
