Noises in area of center console in W 166

Topic number	LI68.20-P-053607
Version	3
Design group	68.20 Center console
Date	07-09-2014
Validity	W166 up to VIN166 ~A110034 / Production date 31.7.2012
Reason for change	Update
Reason for block

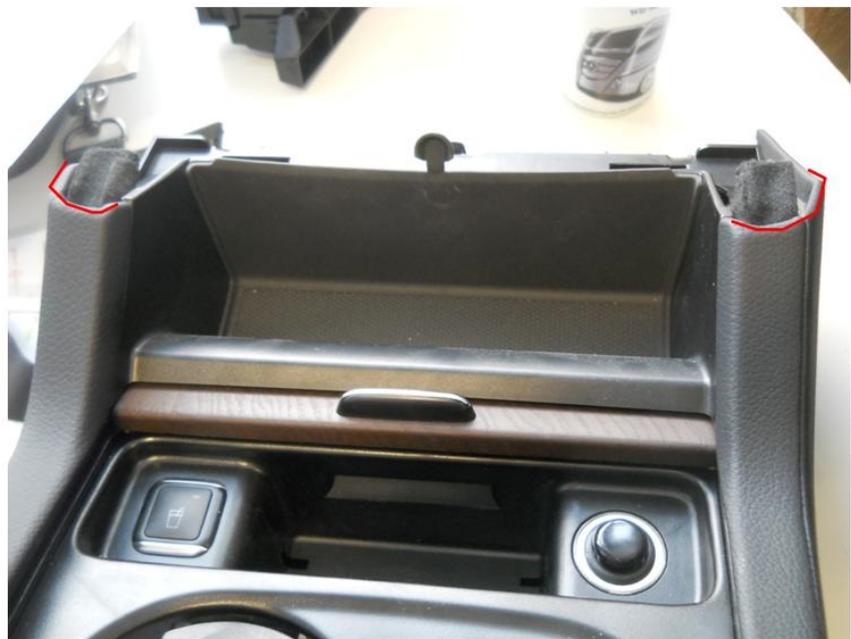
Bild1.jpg:

2. Noise in center console ramp area:

Mounting console does not need to be removed here (see picture 1)

Apply thin coat of special lubricant (A000 989 35 60) between center console ramp and cockpit.

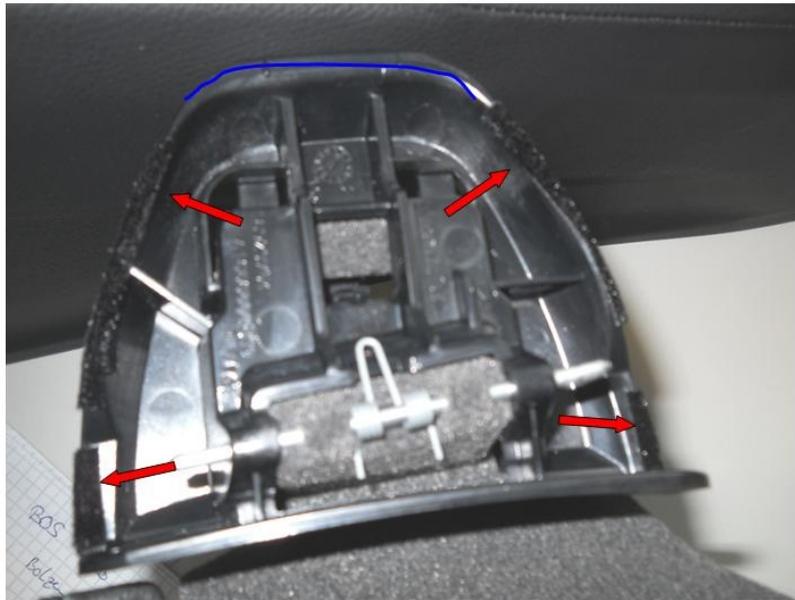
Bild2.jpg:

4. Noise in armrest handle area:

Unclip cover in direction of travel (picture 2). Check felts and install felts if missing (red arrow).

Apply special lubricant (A000 989 35 60) at marked points (marked in blue).
