Creaking noise in transition area between instrument panel and center console on model series 222 / 217

Topic number	LI68.20-P-059330
Version	1
Design group	68.20 Center console
Date	07-03-2014
Validity	Model series 222 and 217
Reason for change	
Reason for block

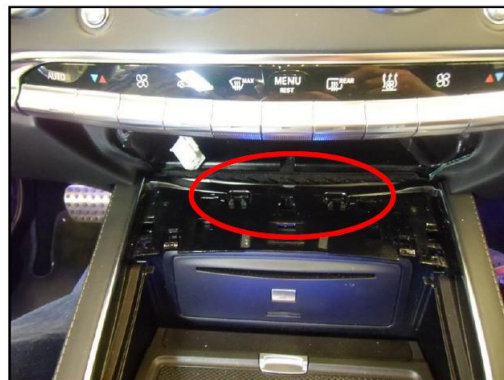
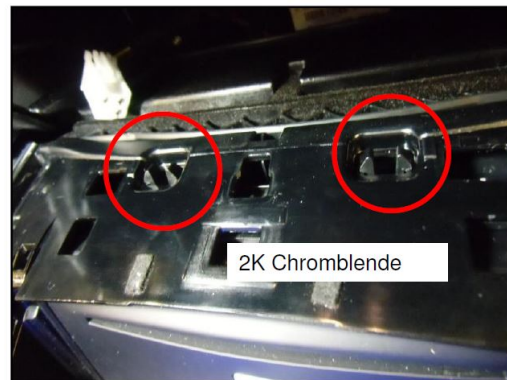
Unbenannt.JPG:

The noise is generated at the clipping point between the chrome molding and the cup holder on the stowage compartment.

Attachments	
File	Description
Unbenannt.JPG	Application points for lubricant

1. Remove trim piece of front center console (AR68.20-P-2101LF).
2. Apply lubricant (A 000 989 36 60) to clipping points (see picture).
3. Install trim piece of front center console (AR68.20-P-2101LF).
