Noises from seat adjuster

Topic number	LI91.10-P-048504
Version	2
Design group	91.10 Front seats
Date	07-10-2014
Validity	Model series 221 and model series 216
Reason for change	Damage code and WIS reference updated
Reason for block

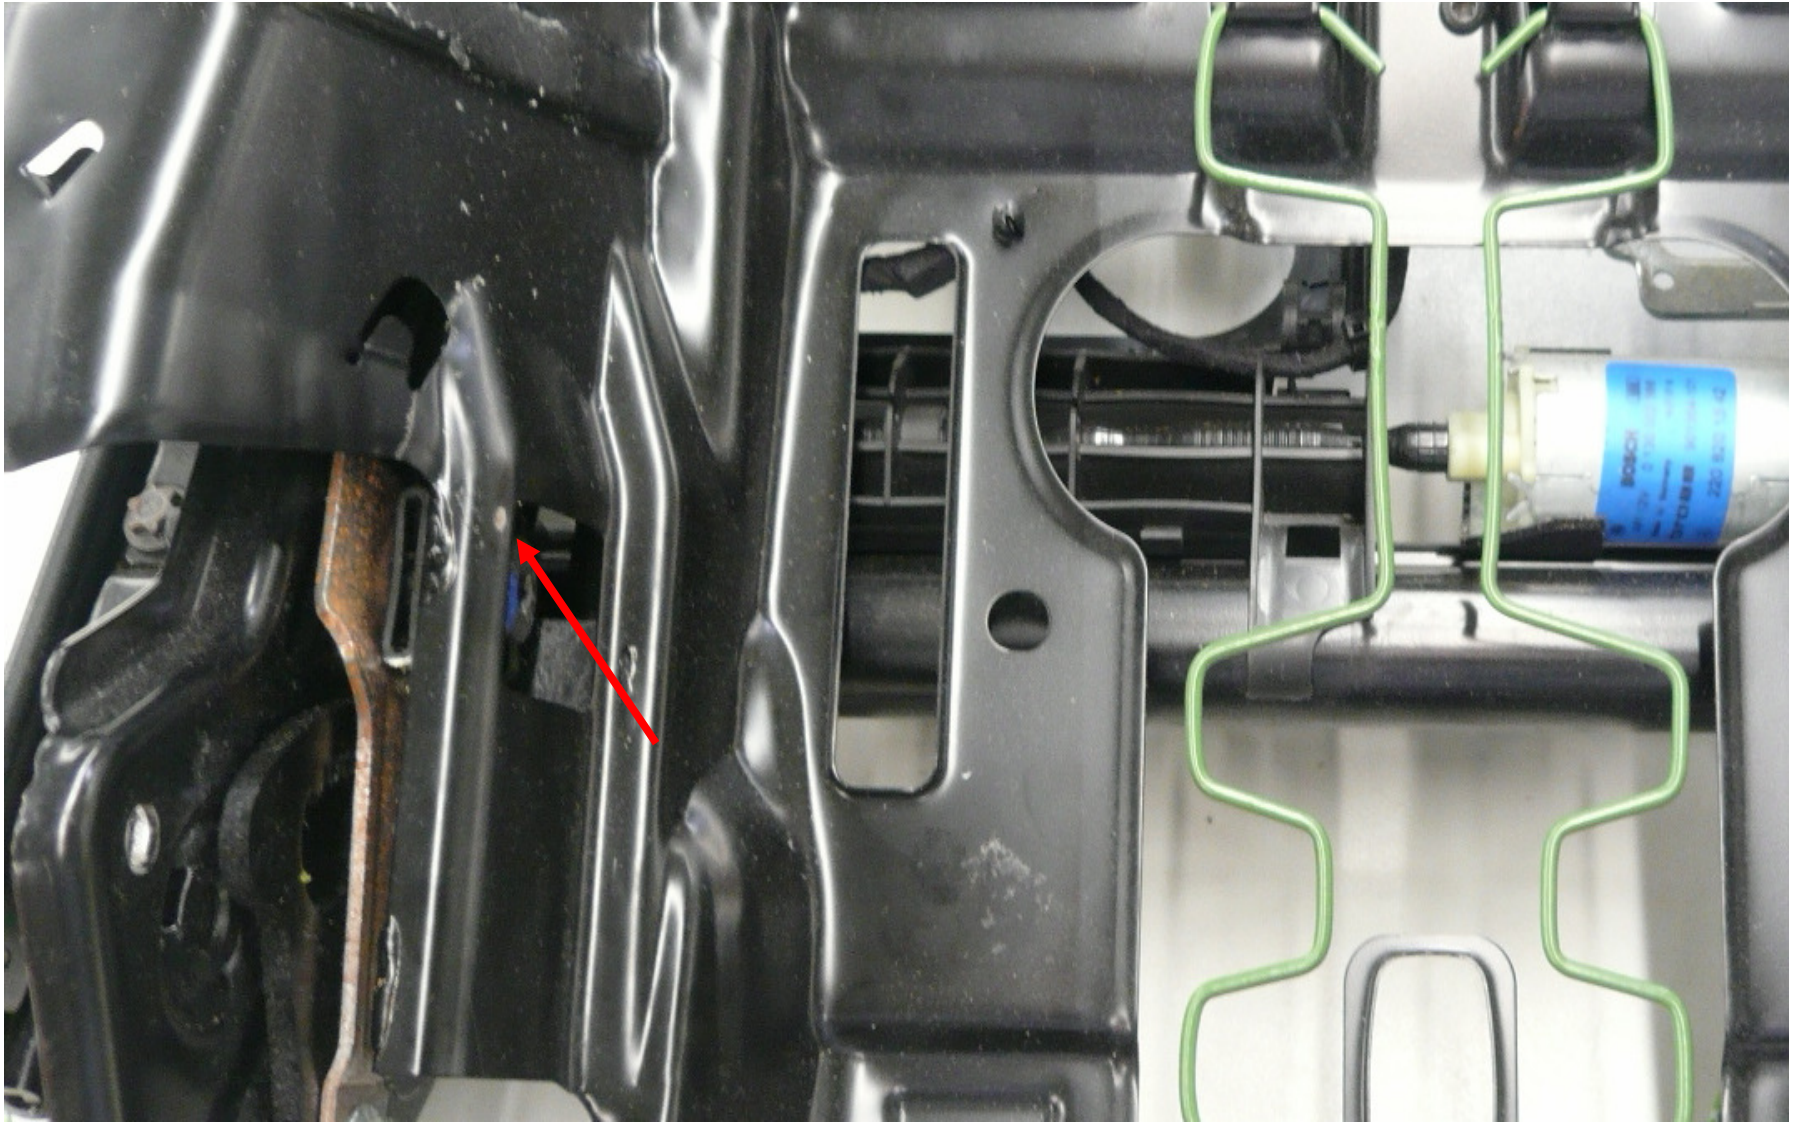
Abrasion of wire frame in seat cushion.

D) If noises can still be heard in the area of the seat cushion, this may be caused by the foamed wire frame rubbing against the cushion shell.

2. Check cushion shell for points of abrasion (see picture and cover with felt)

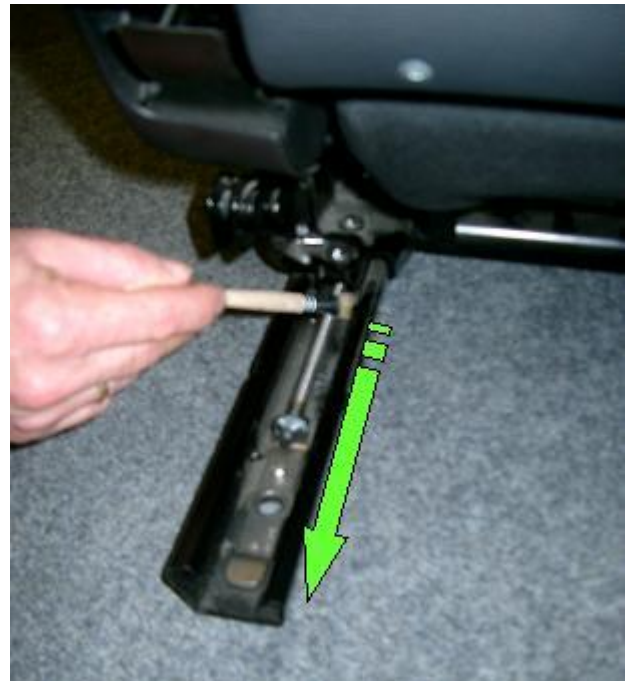
Bild 2.JPG:

Contact between upper and lower rail at rear end of tunnel-side seat rail / seat fore/aft adjustment.

Seat rails not greased sufficiently.

1. Move seat fore/aft adjustment to the front (see picture 1).
2. Move seat height adjustment (rear) upward (see picture 1).
3. Use a brush to apply grease (A 002 989 07 51) to lower rail on tunnel side in the area shown (see picture 2) and spread the grease film to the end of the seat rail (see picture 3).
4. Thoroughly clean upper and lower areas (see picture 4) of door-side rail and apply grease (A 002 989 07 51) with the aid of a brush.
