# Electric seat adjustment, seat heater/seat ventilation of front seat, or rear monitor nonfunctional

Topic number	LI91.29-P-053247
Version	2
Design group	91.29 Seats - electrical system
Date	07-10-2014
Validity	Model series 166
Reason for change	Rear monitor added as possible fault
Reason for block

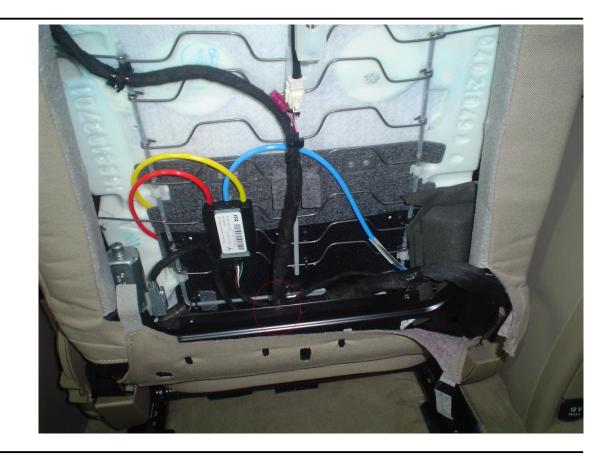
Pic1.jpg:

Seat wiring harness damaged in area of backrest (see Pic?	l).
Attachments	
File	Description
Pic1.jpg	Damaged area

- Remove seat-back lining from seat on left and right.
- Repair damaged area of wiring harness according to approved instructions.
- Cover the panel edge in this area on both seats with felt.
- Then perform a function test.
- Assemble in the reverse order.
