### Traces of oil in area of oil cooler (inner V) on engine 642

Topic number	LI18.30-P-055434
Version	2
Design group	18.30 Oil cooling system
Date	02-10-2014
Validity	All passsengercar / light truck models with engine 642
Reason for change	Part number updated
Reason for block

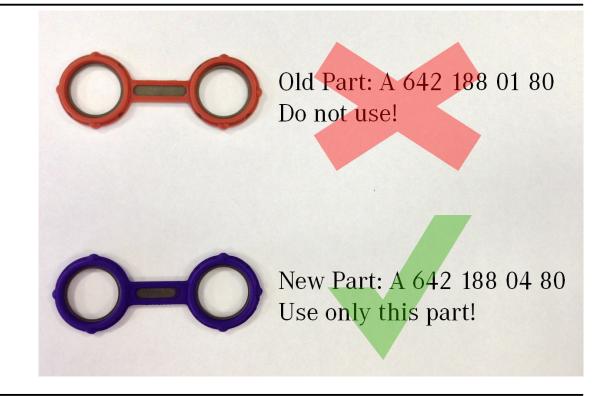
new\_gasket.jpg:

Seals between engine block and oil cooler may be leaking due to incorrect installation.

Attachments	
File	Designation
new_gasket.jpg	Picture of old and new Orings

Replace seals, observe installation instructions.
