Creaking noises from area of air suspension strut on front axle

Topic number Ll32.22-P-058342

Design group 32.22 Air suspension

Validity MODEL 222 4MATIC with AIRMATIC (code 489)

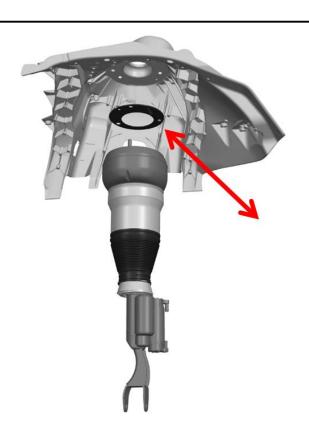
1.JPG:

When cornering, the axle kinematics can result in contact between components inside the suspension strut, which can cause creak or knocking noises. In order to rectify this effect, some vehicles are factory-fitted with square tapered washers (see Figure 1).

In individual cases, however, noises may still occur depending on the tolerances of the components.

In the event of complaints, remove the square tapered washer on the outer wheel.

If it is found that the noise is produced by the inner air suspension strut, a square tapered washer must be installed on the inner air suspension strut.

The installation position of the washer is defined by the positioning of the bolt holes and by the labeling.
