Service Campaign Bulletin

Campaign No. 2014020003, February 2014

SUBJECT: **Model 204 (C-Class), Model Year 2014**
Rework Seam Seal at Spare Tire Well

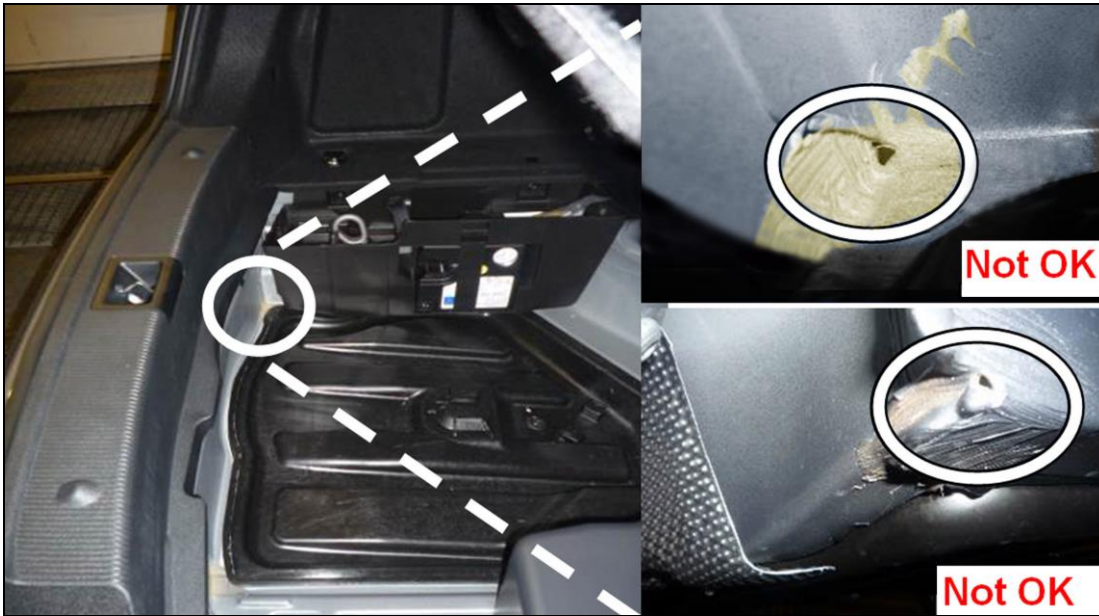
Figure 1

1. Check seal seam in area of spare tire well:
 - Check seal seam on marked corner area (Figure 1) inside of spare tire well.
 - Lift vehicle with vehicle lift.
 - Check seam seal on marked corner area (Figures 1, 3) outside of spare tire well.

2. Thoroughly clean seal seams and then degrease with silicone remover (shop supply).
3. Apply missing seam sealant on outside and inside on spare tire well (Figures 2 and 3).
