## Noises from individual rear seats

| Topic number | LI91.12-P-057916 |
| Design group | 91.12 Rear seats |
| Validity | Model series 222 with code 223 or 224 |

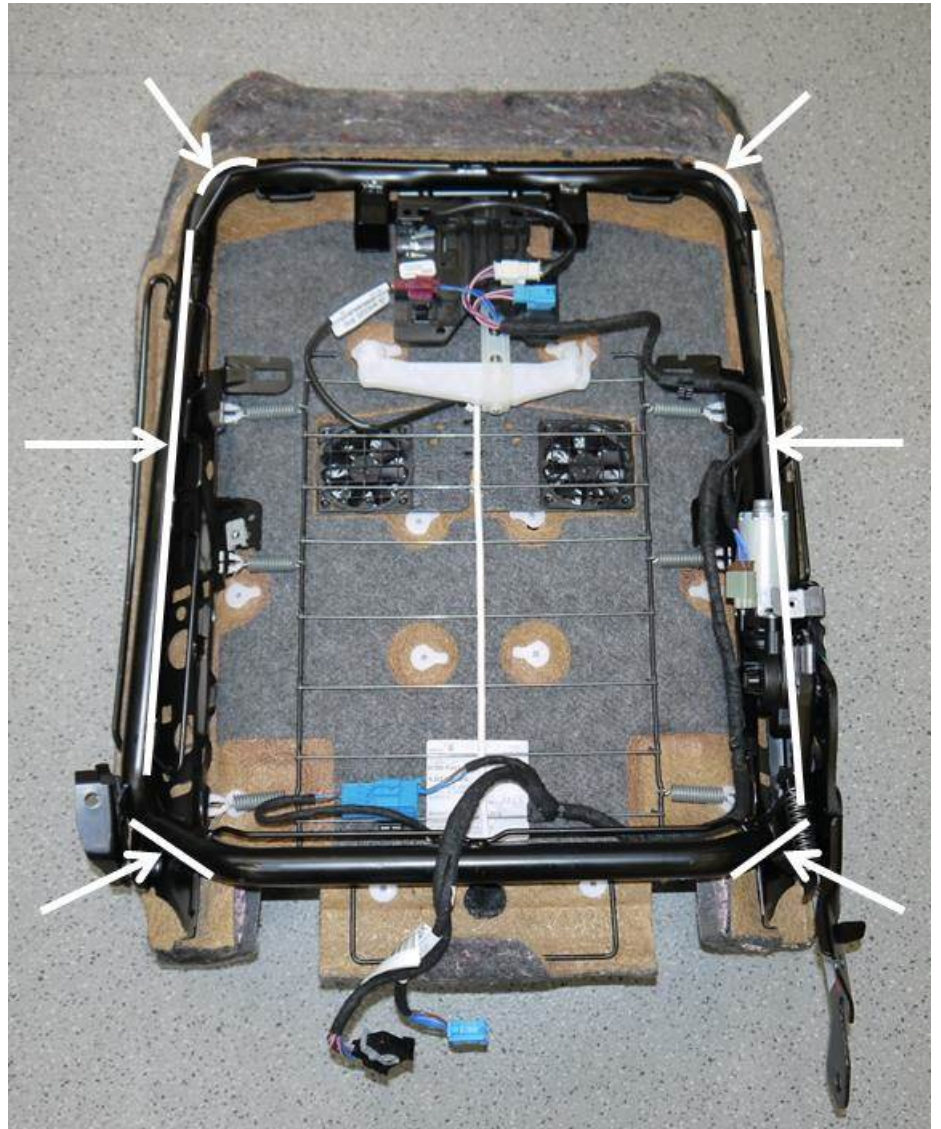
PIC\_1.jpg:

| Attachments | |
|---|---|
| PIC_1.jpg | Position of felt pieces on backrest frame |

1. Remove backrest
2. Remove backrest padding
3. Attach felt material to the backrest frame (see picture PIC\_1)
  - At the lower radii
  - At the side frame elements
  - At the upper radii
4. Attach felt material to the rear of the rear backrest padding (not with SA code 406!) (see picture PIC\_2)
  - Felt size 70x320 mm
5. Apply a care product to the seat cover and wheel well liner in the area of the contact surfaces between the individual rear seat backrests and the wheel well liner at the C-pillar  
(see pictures PIC\_3, PIC\_4 and PIC\_5)
6. Apply a care product to the seat covers in the area of the transition from the rear backrest to the center armrest  
(see picture PIC\_6)

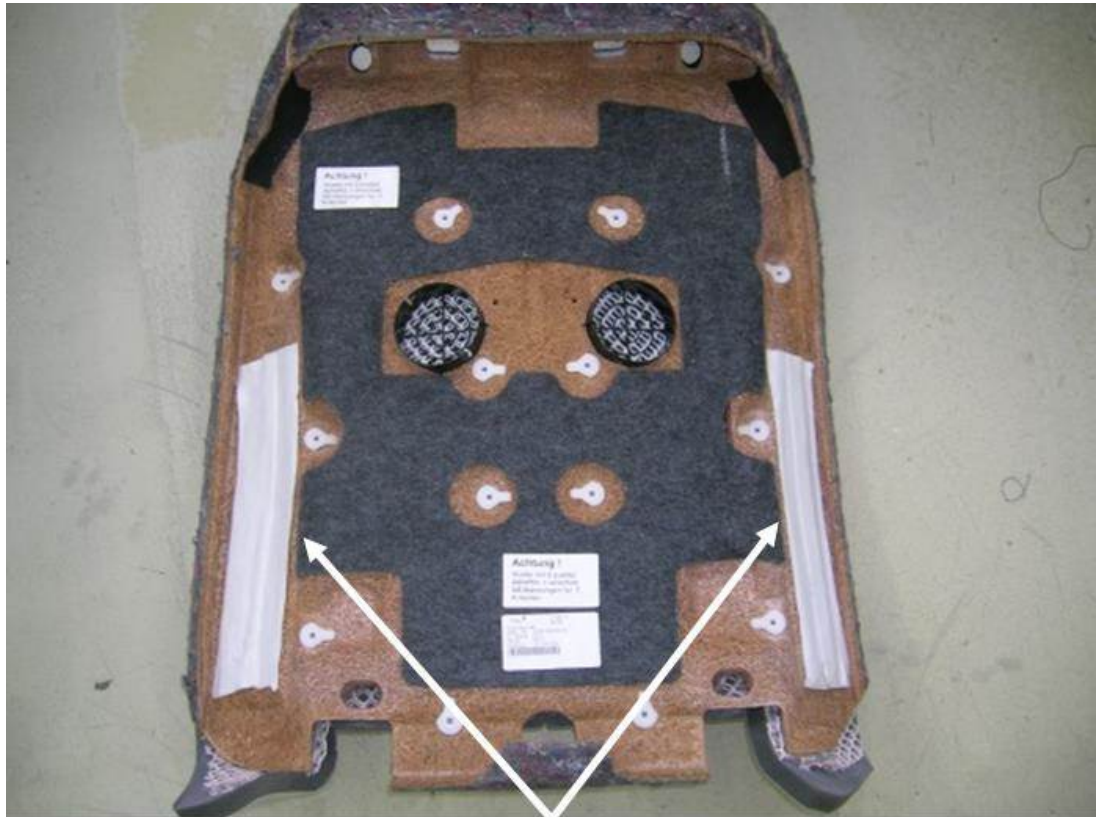
PIC\_2.jpg:

| Attachments | |
|---|---|
| PIC_2.jpg | Position of felt pieces on rear of padding |

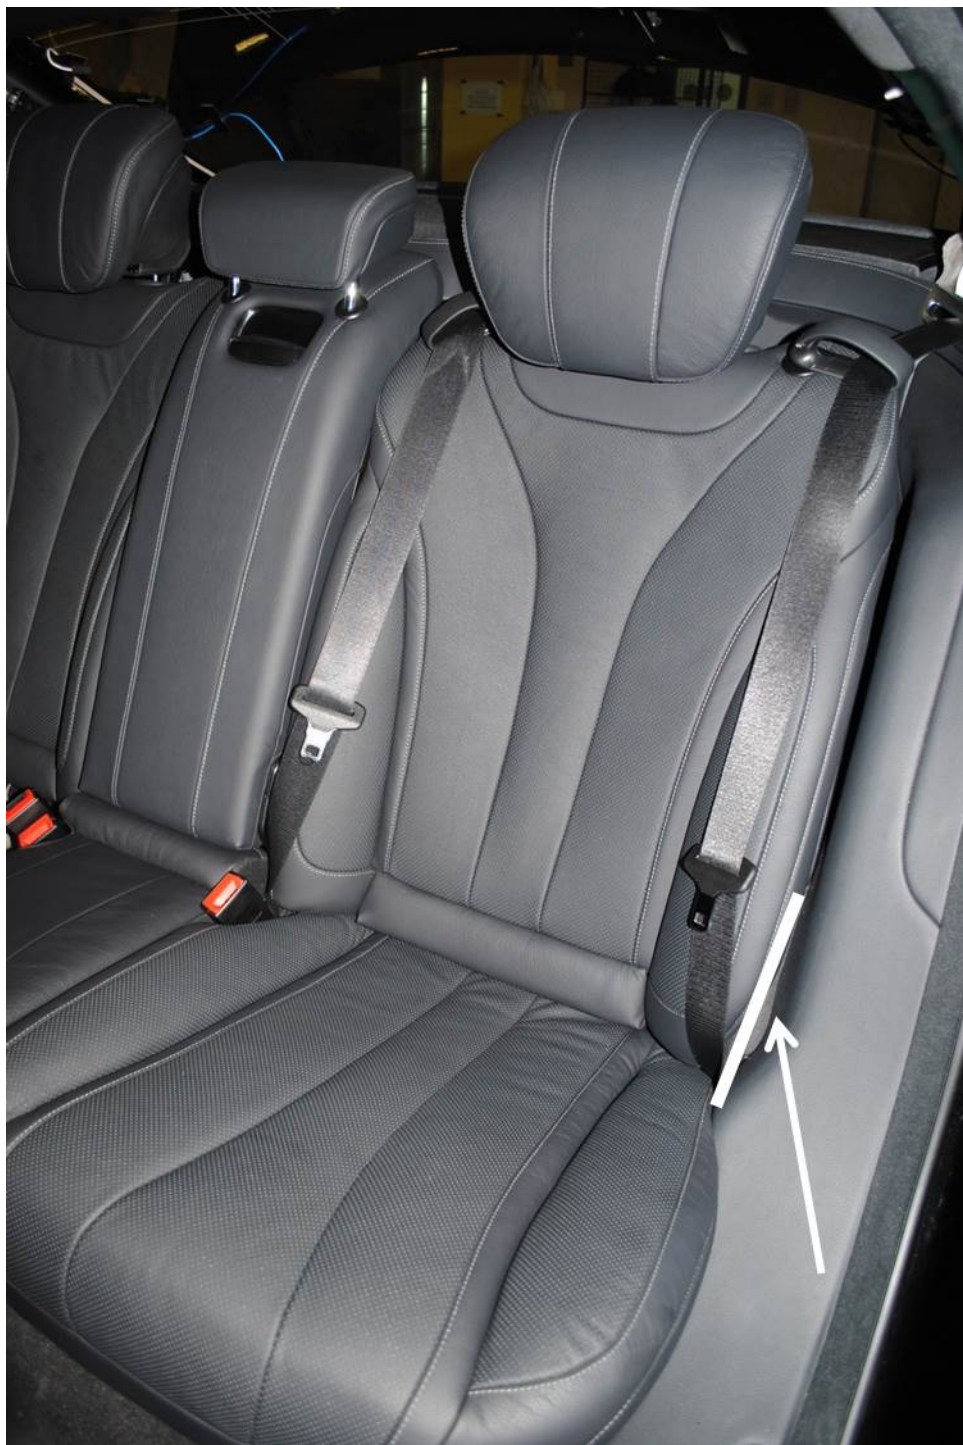
PIC\_3.jpg:

| Attachments | |
|---|---|
| PIC_3.jpg | Area between individual rear seat backrest and wheel well liner |

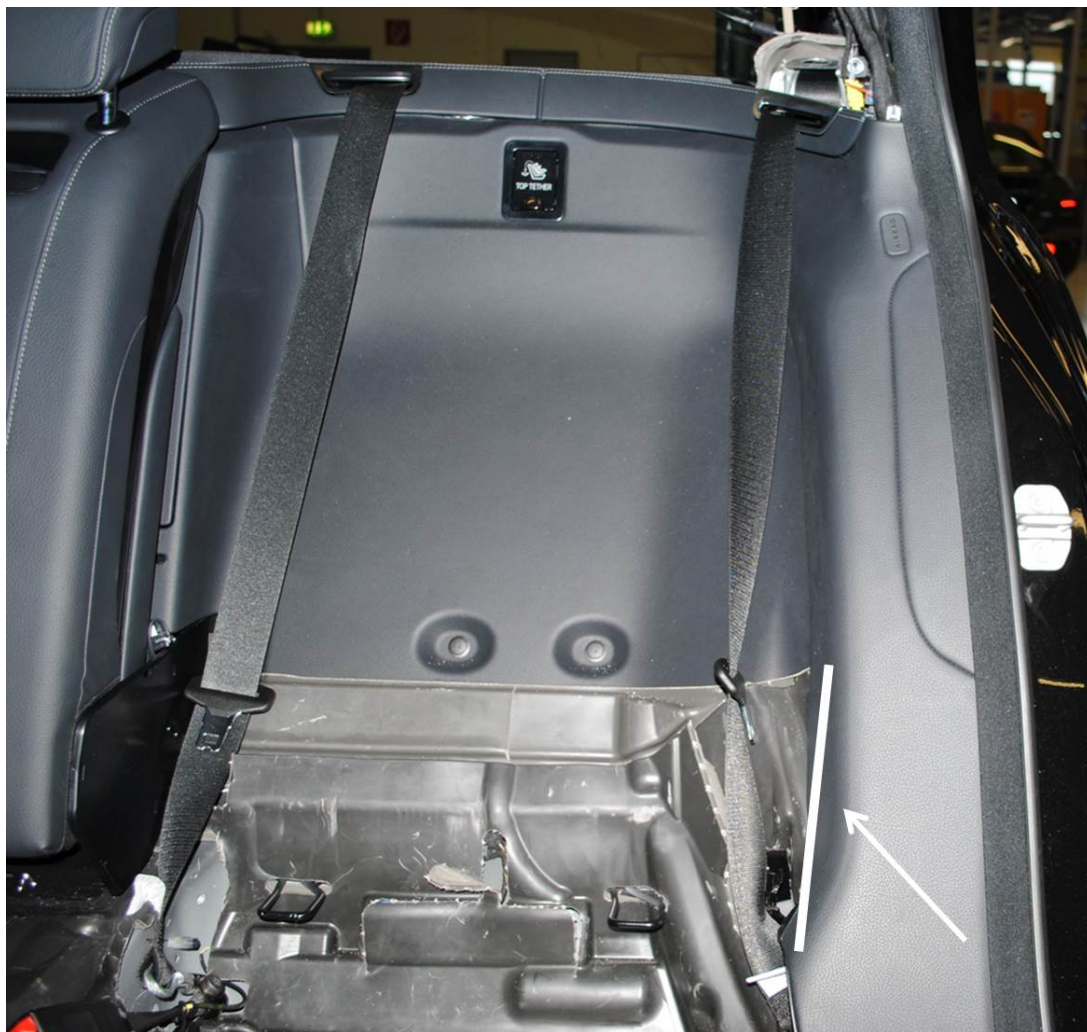
PIC\_4.jpg:

| Attachments | |
|---|---|
| PIC_4.jpg | Area of wheel well liner |

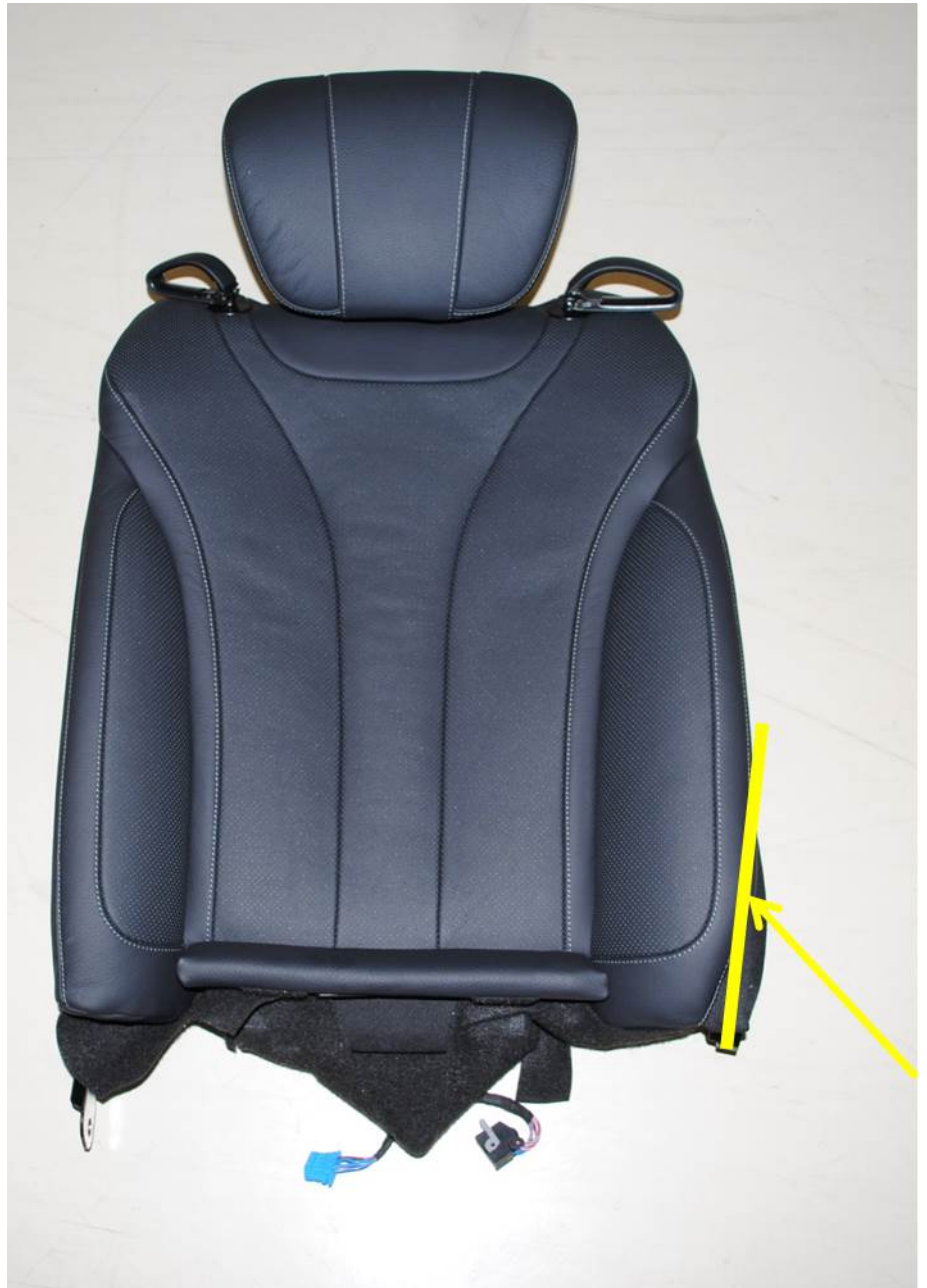
PIC\_5.jpg:

| Attachments | |
|---|---|
| PIC_5.jpg | Area of cover of individual rear seat backrest |

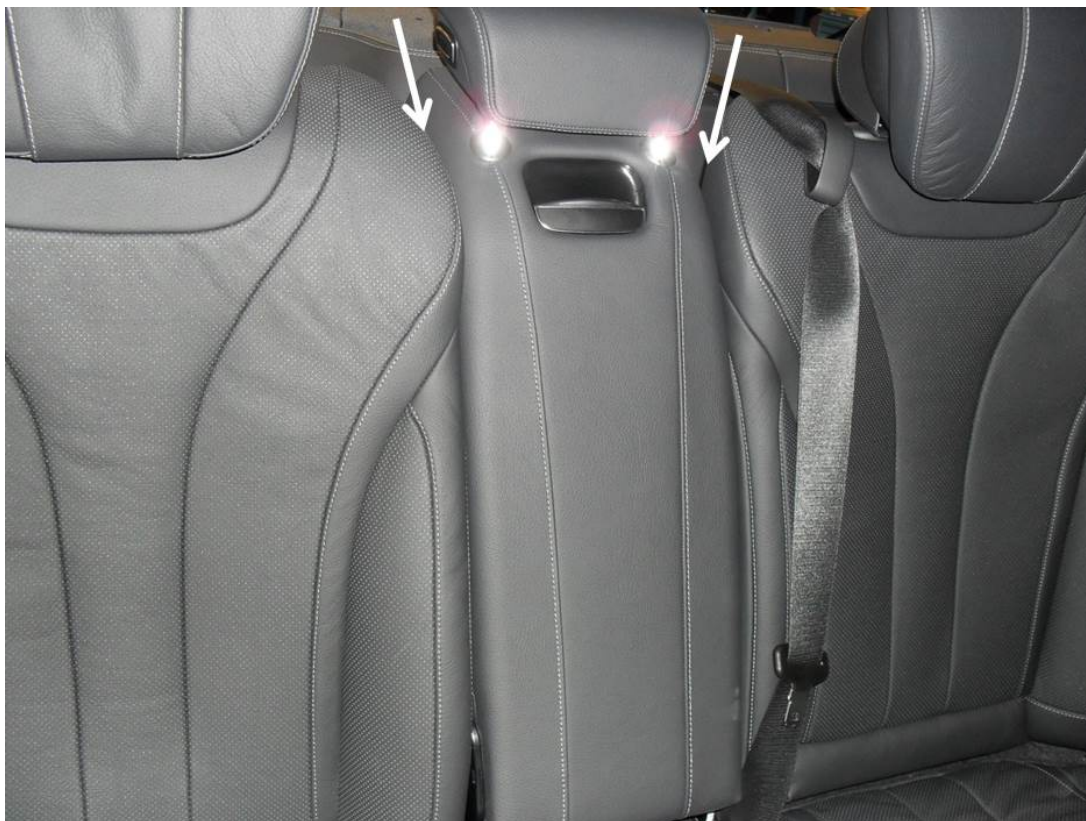
PIC\_6.jpg:

| Attachments | |
|---|---|
| PIC_6.jpg | Area between individual rear backrests and center armrest |
