## Creaking noises in area of center console for model series 117

Topic number	LI68.20-P-058781
Version	1
Design group	68.20 Center console
Date	03-31-2014
Validity	Model series 117 up to production date 24.02.2014
Reason for change	Modified validity for US market Added parts disclaimer
Reason for block

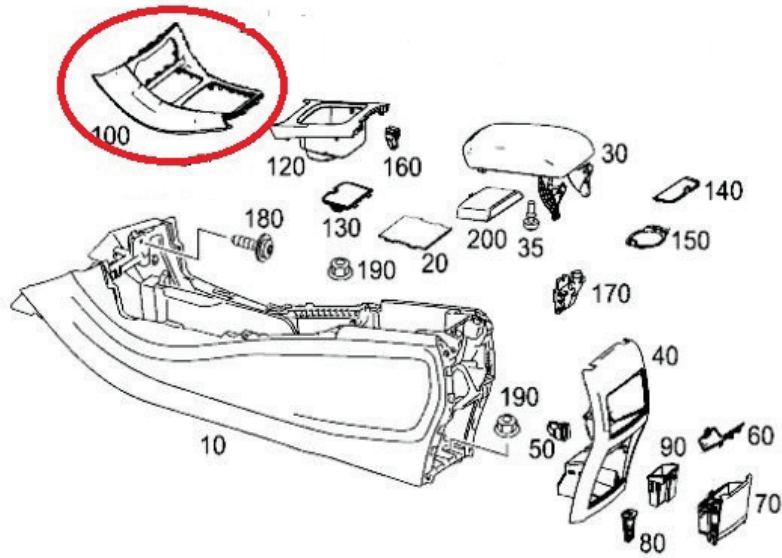
1.JPG:

Creaking noises in area of center console.

The trim on the A/C operating unit makes noises.

Attachments	
File	Designation
1.JPG	EPC picture

Replacement of trim on A/C operating unit.

Determine the optimized trim parts via the EPC.
