Replace belt holder/ belt retaining tab on trunk side panel, model series 166

Topic number	LI68.30-P-058750
Version	1
Design group	68.30 Coverings, trim
Date	03-25-2014
Validity	Model series 166
Reason for change	
Reason for block

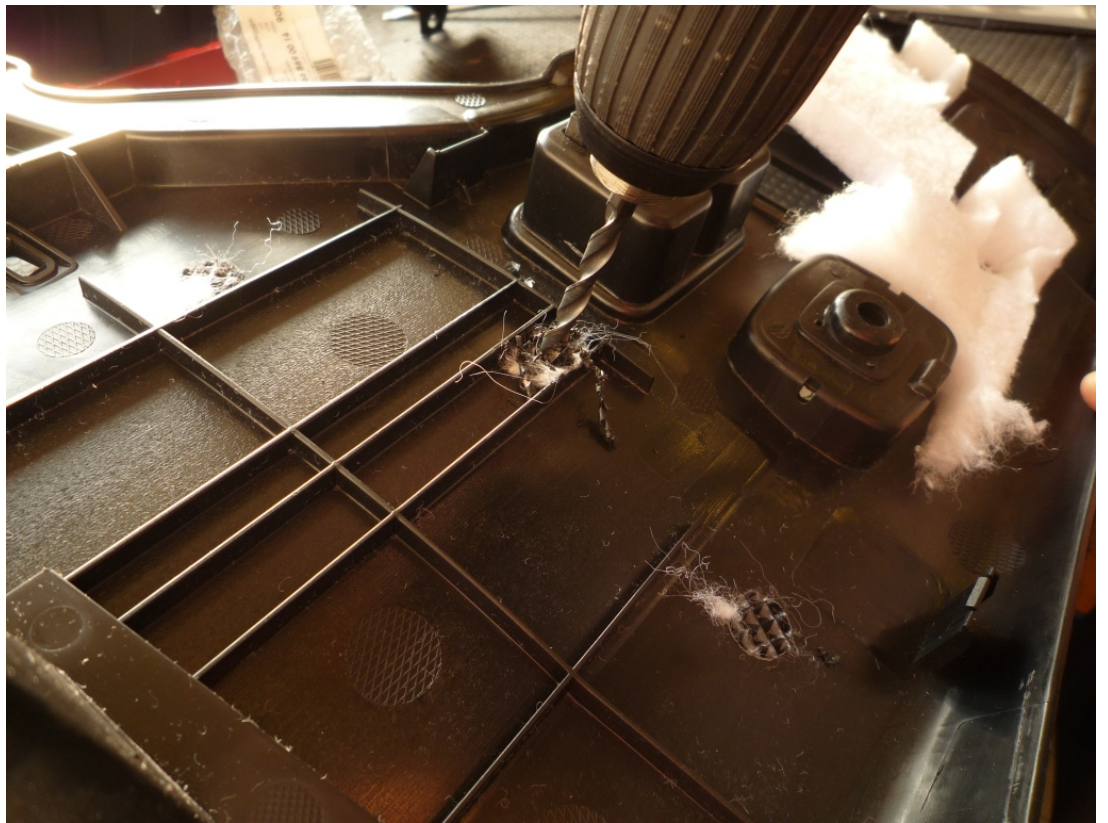
Bild1.JPG:

Belt holder/ retaining tab on side paneling in trunk is broken.

This is NOT covered by warranty! Massive external influence causes the belt holder to break off the trunk side panel. These repair instructions are intended to offer the customer an expert and affordable repair option.

1. Remove side paneling in trunk. (ar68.30-p-4800GQX).
 2. Drill out the broken retaining tab from behind using a 6.5 mm drill bit positioned in the center and remove the tab (Figure 1).
 3. For the retaining tab of the 3rd seat row, the upper stiffening rib must be modified and recessed (Figure 2).
 4. Screw a tapping nut carefully onto the retaining tab (Figure 3 /4).
- Remark: Some slight movement of the retaining tab will remain.
5. Install side paneling in trunk. (ar68.30-p-4800GQX)
