Campaign No. 2014020004, March 2014

Service Campaign Bulletin

SUBJECT: Models 212 (E-Class), 218 (CLS-Class), Model Year 2014 Check Weld Seam at Rear Axle Cross Member at Left and Right, Rework if Necessary

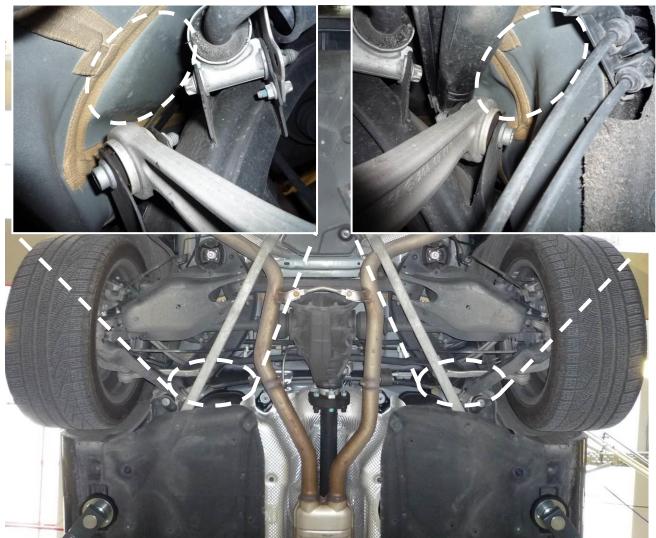
Figure 1

- 1. Lift vehicle on vehicle lift.
- 2. Check weld seam (in area circled, Figure 1) at right/left rear axle cross-member for crack using mirror:

- If weld seam is **OK**: Procedure is complete.
- If weld seam is not OK (Figure 2): Proceed to Subject B.
