Technical product information

Topic	Mulsanne front suspension - control module parameter updates
Market area	Worldwide Bentley (1WBE)
Brand	Bentley
Transaction No.	2032620/2
Level	EH
Status	Approval
Release date

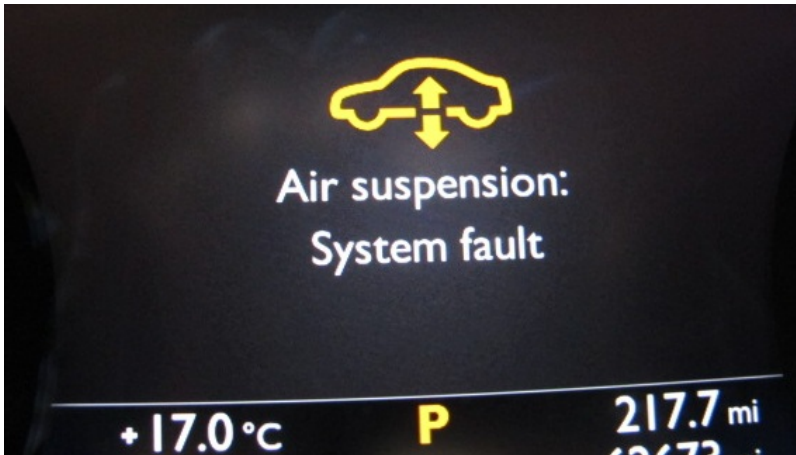
Figure 1

The air suspension warning light (Figure 1) is illuminated and/or event codes C103429 (Front left hand ride height sensor) and C103529 (Front right hand ride height sensor) are present within the air suspension control module.

The parameters of the front ride height sensors are insufficient, this TPI describes the process which must be followed should the air suspension warning light be evident and/or the suspension control module event codes are logged relating to the front ride height sensors.
