Field campaign

Topic	GTC hood ram – cover deletion (SC14/13)
Market area	United Kingdom E01 Bentley UK (6E01), Germany E02 Bentley rest Europe (6E02), United States E05 Bentley USA and rest America (6E05)
Brand	Bentley
Transaction No.	2037493/3
Campaign number	EA13
Note	
Type	Service campaign
US code

New GTC

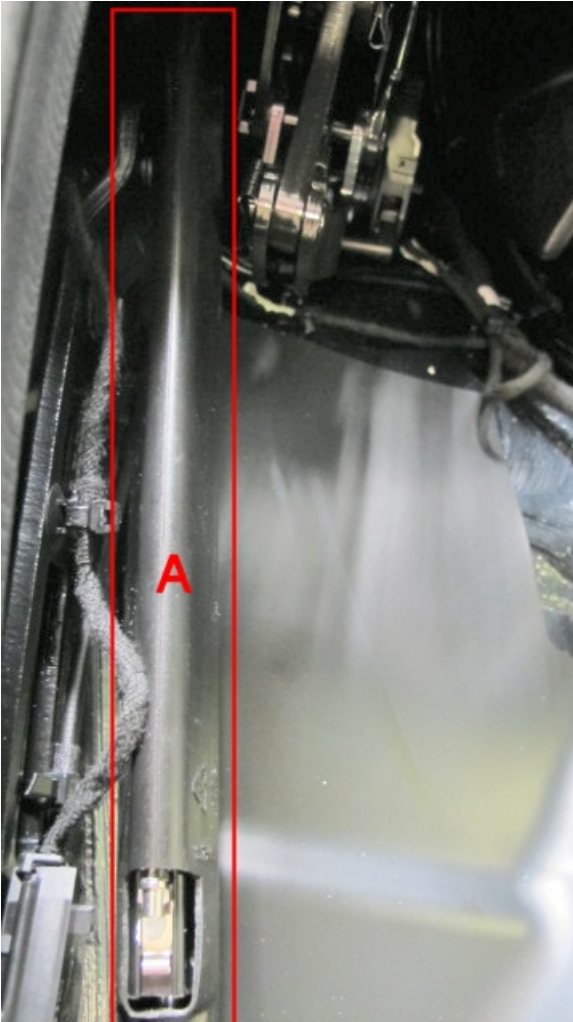
Figure 2

A recently introduced cover fitted to the tonneau ram may clash with the hood mechanism and potentially cause the system to malfunction. Initial investigations have determined that this cover has to be removed until the cause of the clash is understood. Therefore the 8 cars currently fitted with this part should have the following operation performed before delivery to customer

2. Identify the plastic cover 'A' fitted to the tonneau ram (see Figure 2)

Remove the plastic cover from both rams then over tape the ends of the ram with protective tape
