Field campaign

Topic	Tonneau micro switch – mounting bush orientation (SC14/21)
Market area	Bentley: worldwide (2WBE)
Brand	Bentley
Transaction No.	2037971/1
Campaign number	EA21
Note	
Type	Workshop campaign
US code

New Continental GT Convertible

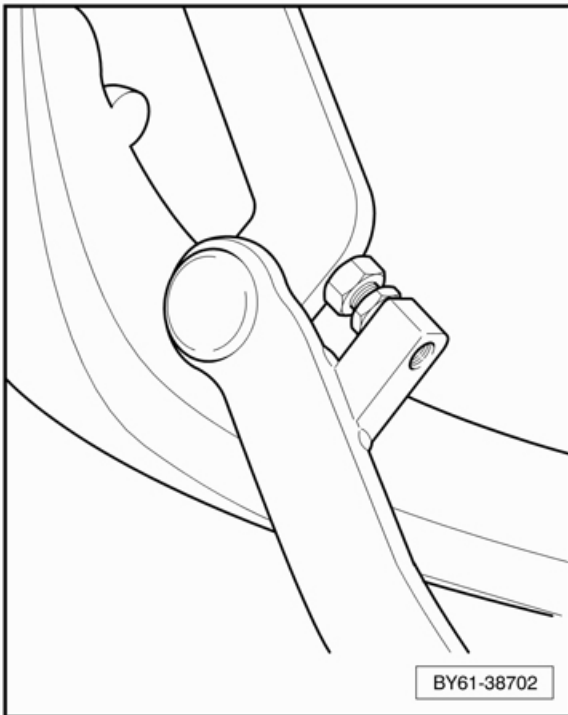
Figure 1

1. With the ignition on, partially raise the power operated roof until the tonneau cover is held in the vertical position and secured against the lock stops on the hinge mechanism (see Figure 1)

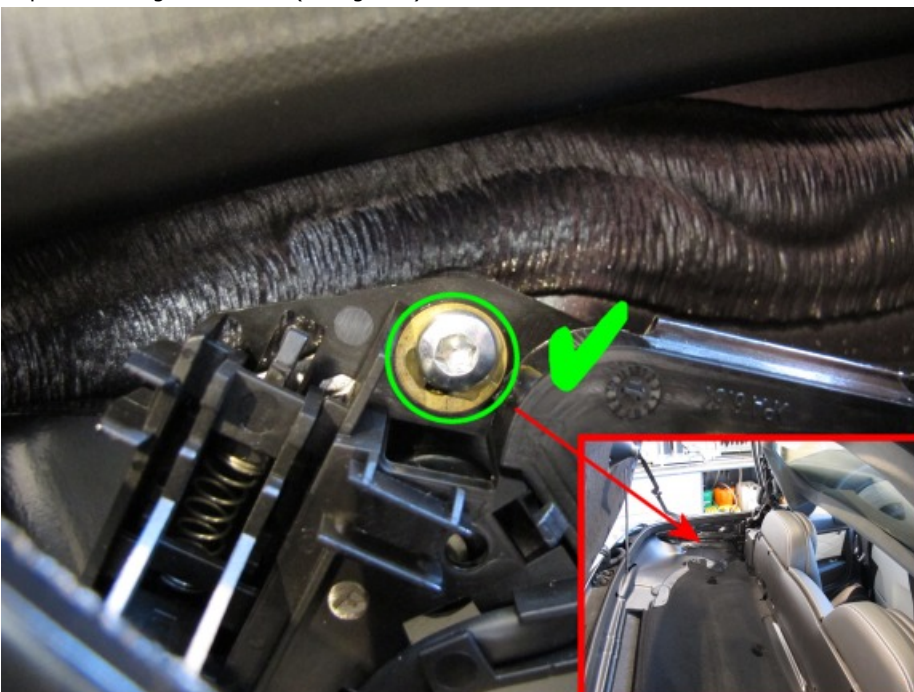
Figure 2

2. Referencing figure 2 locate the tonneau cover hinge micro switch assembly, it is located on the left hand tonneau hinge

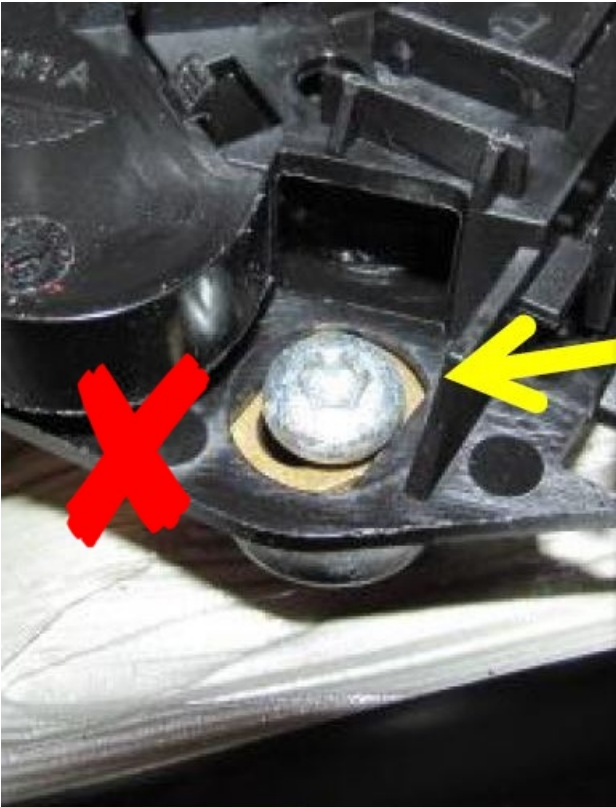
The tonneau position micro switch assembly is mounted to the vehicle via a brass bush encapsulated in the switch moulding this bush may have been inverted when the switch moulding was formed. When this is the case the switch will become detached from the mounting plate. Ultimately the convertible roof system will fail to operate.

3. Inspect the tonneau cover hinge microswitch assembly securing bush. Figure 2 shows the correctly oriented brass bush with the fastener head bearing on the 'top hat' section of the brass bush. Figure 3 depicts an incorrectly manufacture assembly where the brass bush is inverted and the top hat section is not visible. This failure will result in the switch housing assembly lifting off the bush resulting in the convertible roof failing to operate

The tonneau position micro switch assembly on all applicable vehicles should be inspected. A switch moulding found to be incorrectly manufacture should be replaced
