| Topic | New Continental GT V8T and New Continental GTC V8T - Oil filter by-pass valve (SC14/17) |
| Campaign number | EA17 |

New Continental GT V8T and New Continental GTC V8T

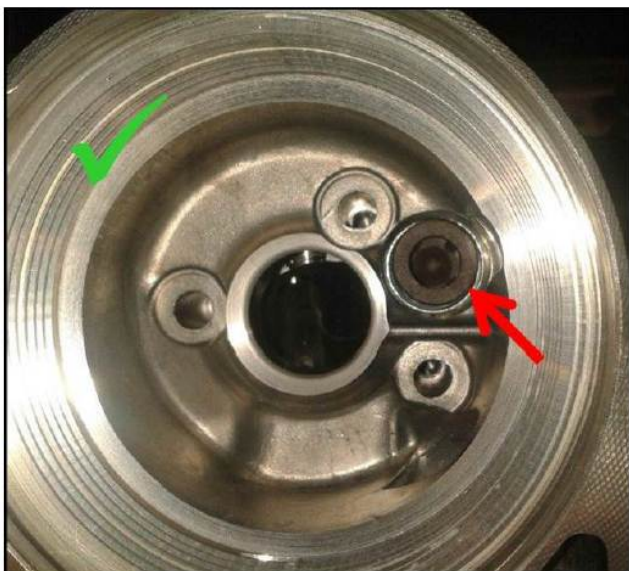
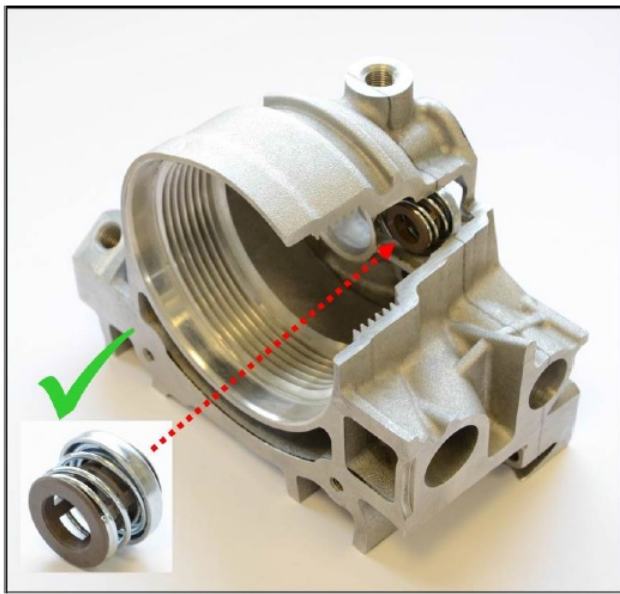
- Visually check the by-pass valve is correctly installed, the orientation of the oil filter by-pass valve should be fitted as shown in Figures 1 and 2, if the by-pass valve is fitted as shown no further action is required
- Once the oil filter is reassembled place a yellow paint mark on the oil filter cap as shown in Figure 7

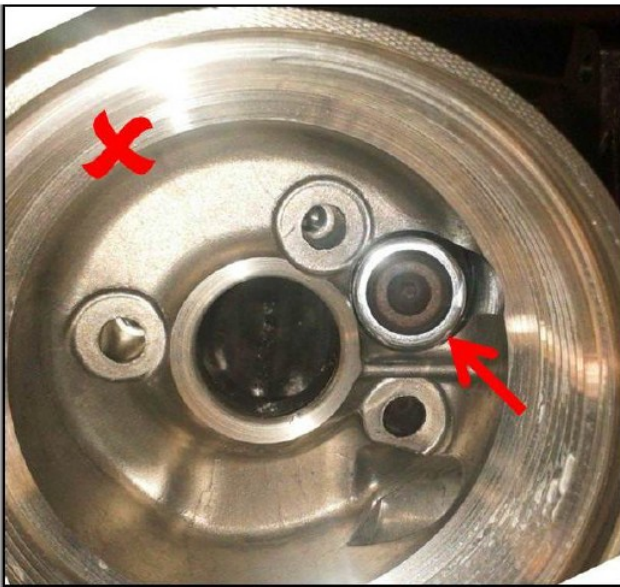
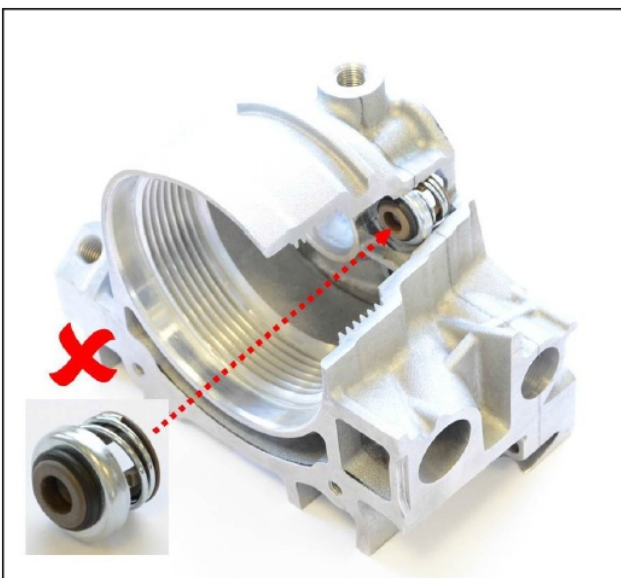
2. In the event that the orientation of the valve is incorrect as shown in Figures 3 and 4 or the valve is missing as Figure 5, please carry out Section 2

1. To remove the existing valve, use a suitable hook/pliers to pull/remove the valve from oil filter housing

On removal of the valve you must wear safety glasses as the valve can break into separate parts upon removal, you must ensure that all pieces of the valve are removed before fitting the new part

3. With extreme care using a rubber mallet fit the valve into the oil filter housing, ensure the valve is fully home and equally seated upon fitment
