<b>Topic</b>	Mulsanne exterior door mirror software update (SC13/03)
<b>Market area</b>	Worldwide Bentley (1WBE)
<b>Brand</b>	Bentley
<b>Transaction No.</b>	2033282/2
<b>Campaign number</b>	E779
<b>Note</b>	
<b>Type</b>	
<b>US code</b>

### Mulsanne exterior door mirror software update

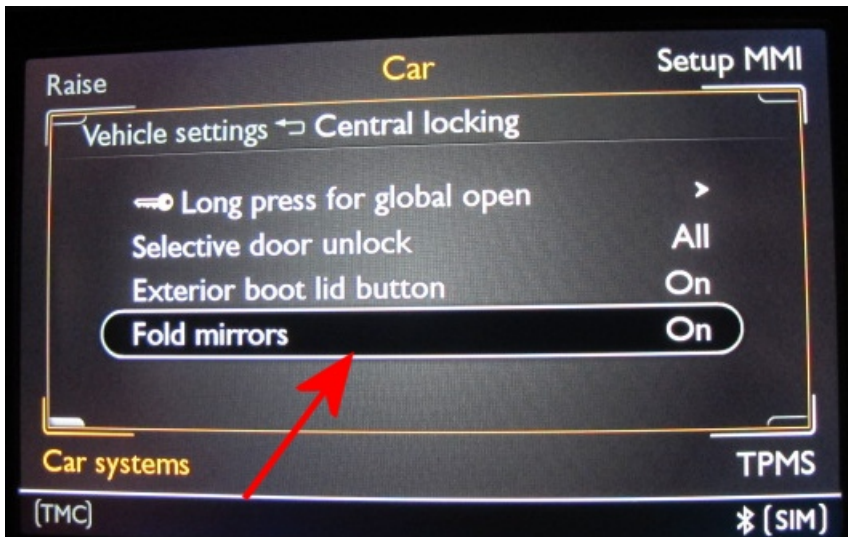
Figure 1

The SVM update also prevents the possibility of a separate mirror related issue from occurring, the issue concerned can occur when the 'Fold mirrors' function is selected to be On within the MMI as shown in Figure 1. Selecting this function allows the mirrors to be power folded when the vehicle is locked.

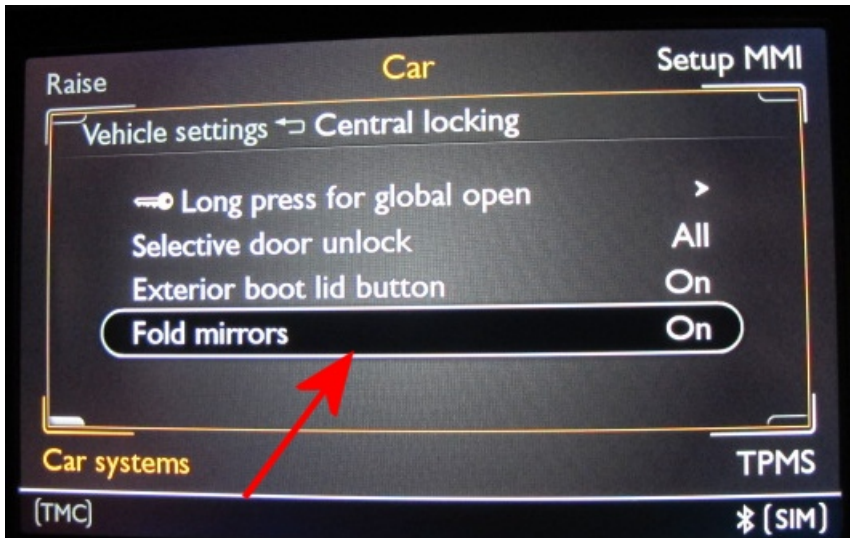
Figure 1

The SVM update also prevents the possibility of a separate mirror related issue from occurring, the issue concerned can occur when the 'Fold mirrors' function is selected to be On within the MMI as shown in Figure 1. Selecting this function allows the mirrors to be power folded when the vehicle is locked.
