Technical product information

Topic	Bentley Continental Series - Power boot close switch - Correct diagnosis
Market area	Worldwide Bentley (1WBE)
Brand	Bentley
Transaction No.	2033745/2
Level	EH
Status	Approval
Release date

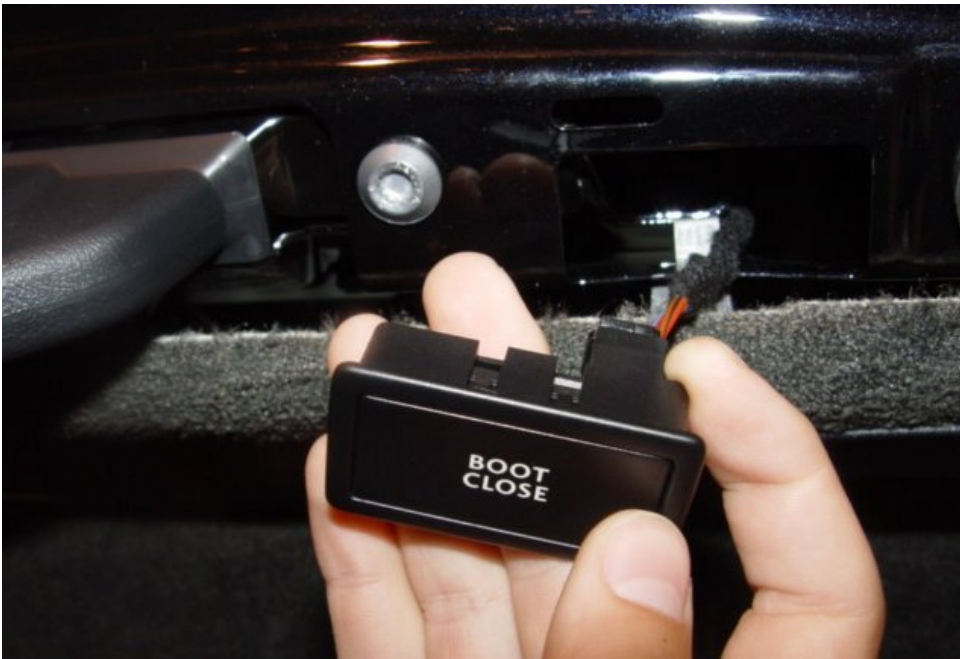
Figure 2

-With the boot close switch hanging in free air press the switch to check if the boot lid starts to close, should this be the case and the boot lid starts to close the switch is serviceable, you should now proceed with procedure 6 **NOTE:** should the boot not start to close proceed to procedure 5

- 4.Reconnect the switch to the electrical connection (Figure 2) allowing the switch to hang in free air

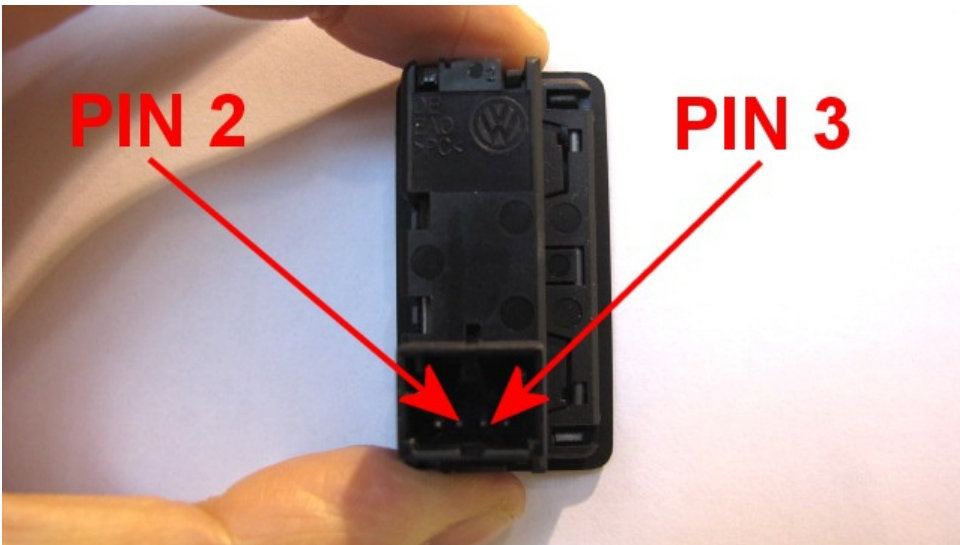
Figure 3

The resistance for a fully serviceable switch when operated (pressed) is 0.2 Ohms

- Measure the resistance between pins 2 and 3 (Figure 3) The button on the boot close switch must be pressed and held in otherwise a correct reading will not be obtained
